WANBOROUGH FLOOD AND DRAINAGE MANAGEMENT REPORT

Wanborough, Swindon, Wiltshire

Revised Report: February 2011

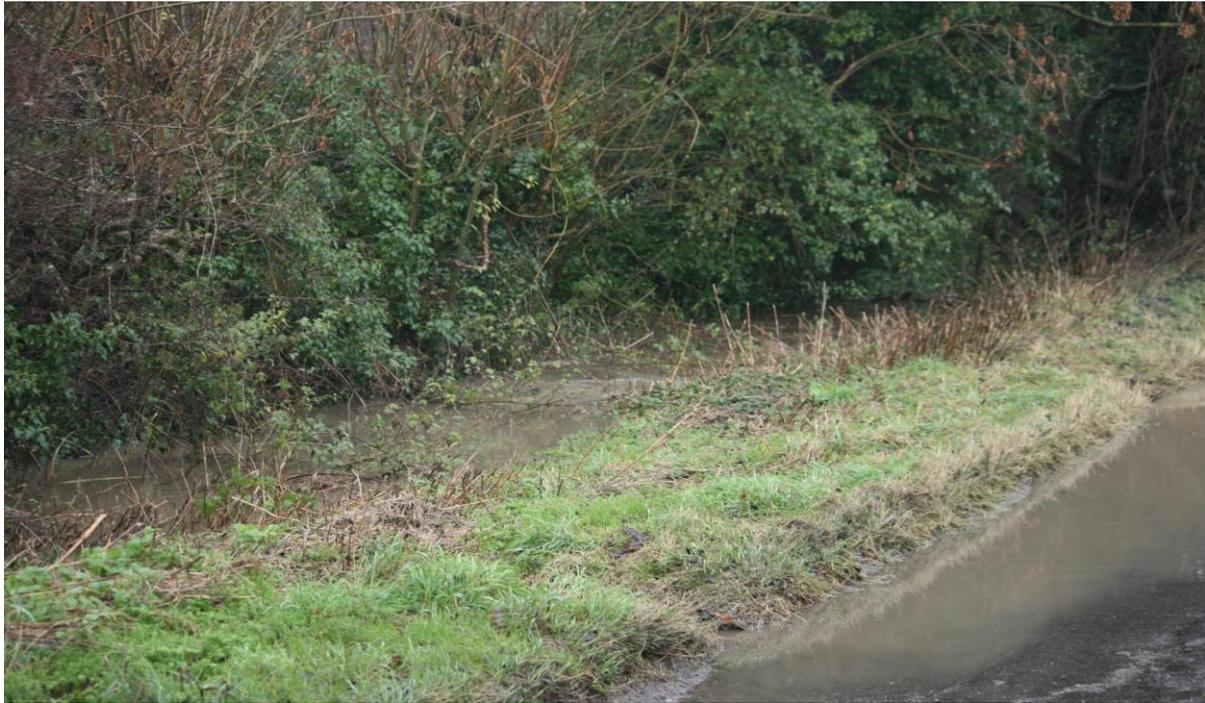
Photo 3.9 (supplied by WPC): shows a section of ditch on the north side of the road in poor condition; the ditch is unable to store and/or convey storm water.

Clearance and maintenance of the ditches is recommended. However, consideration is required for the effects downstream to ensure the risk to properties is not increased. Connecting culverts and ditches will require attention which may include flow control structures to reduce the impact when discharging into the Thames Water surface water sewers; this is covered in a little more detail further on in this chapter. However, a level 2 assessment maybe required to ascertain peak flows and channel and culverts capacities.

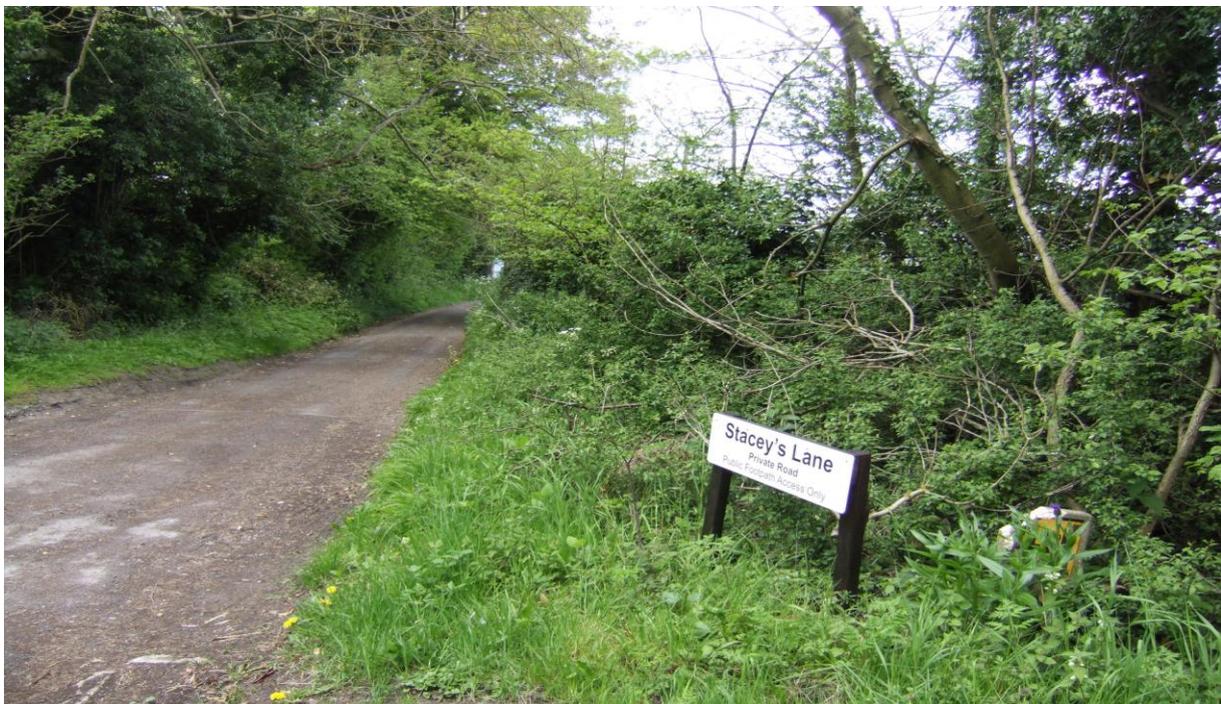
Photo 3.10: During the heavy rainfall events Stacey's Lane acted as a natural flow path and it is considered that there should be a small ditch either side of the lane

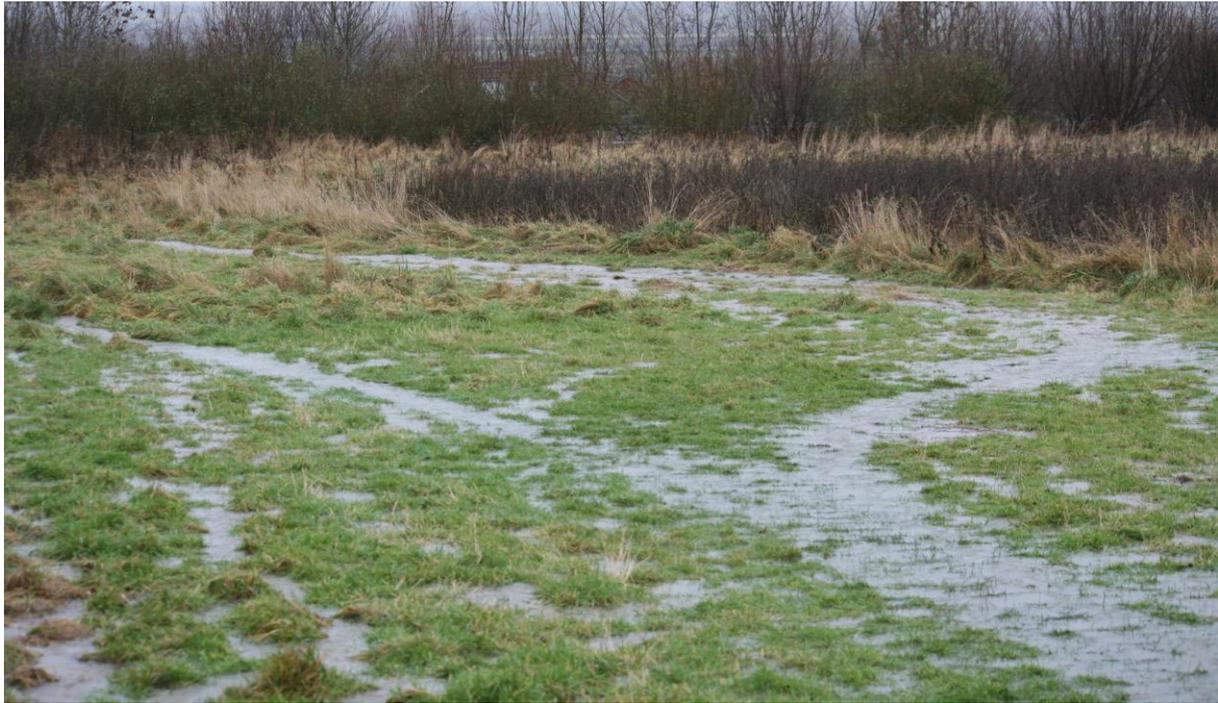
Photo 3.12 (supplied by WPC): view showing spring/surface water flow on western side of field directly behind Springlines, generated during heavy rainfall event of 2007; this water tends to attenuate behind the embankment, as shown in Photo 3.13 below. Further protection for Springlines can be implemented here with the introduction of an infiltration or detention basin. These can be designed with an overflow pipe linking with the ditch or drainage system at either end of the field. Infiltration basins can be constructed along other parts of this field boundary particularly where flow paths are generated. These recommendations are highlighted on the plans in Appendix B.

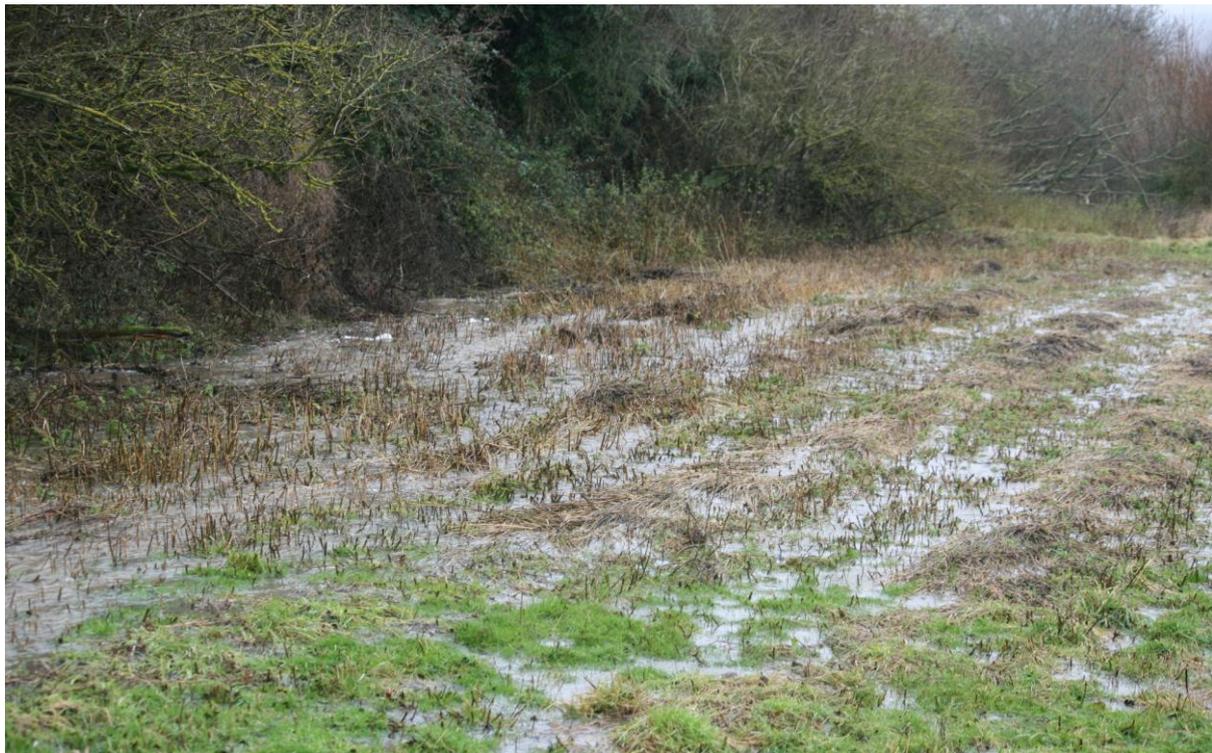
Photo 3.13 (Supplied by WPC): Water being held behind raised embankment area 2007.

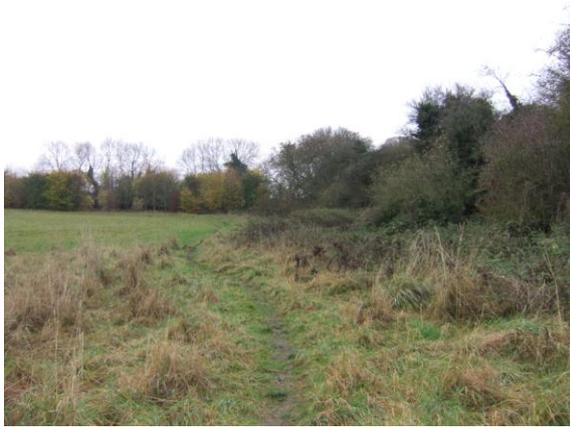
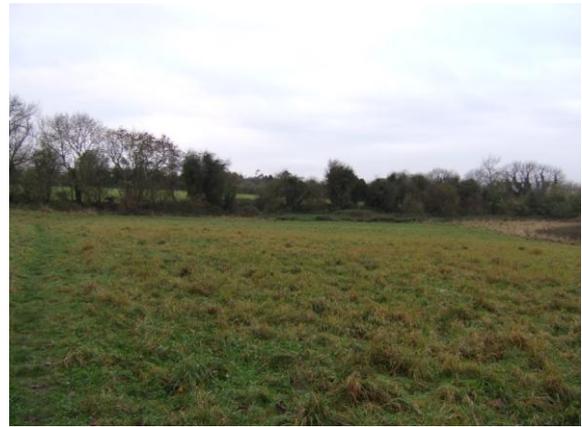
The ditch on the west side of the field is considered the main system for this area and collects water from the highway and the land above it. The ditch is in poor condition and requires reinstating. However, as discussed earlier further investigation is required to determine the effects downstream.

Photo 3.14: view facing south at tree line where original ditch should be; Photo 3.15: view facing west at ditch line.

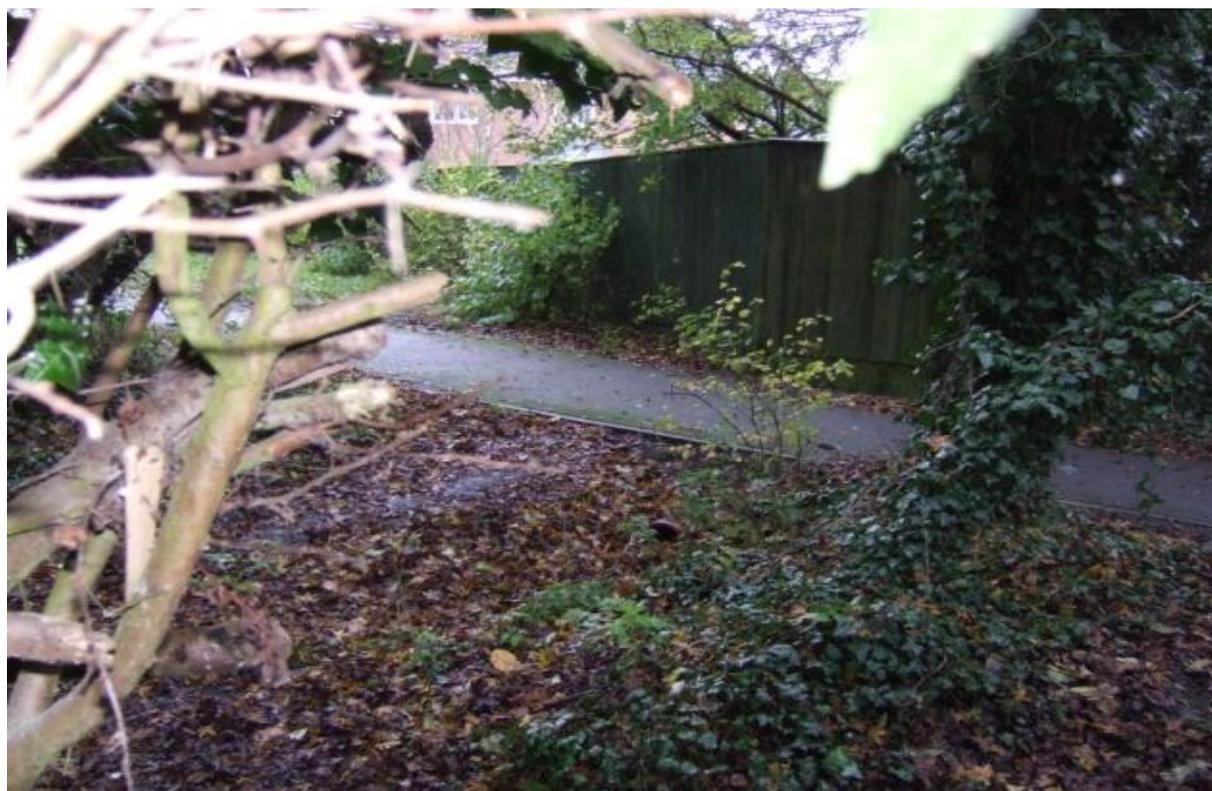
Photo 3.23: shows the culverted section of the intercepting footpath located between Springlines and Oakapple. This is a critical area in a number of ways:

- Water does not flow in line with the culvert as the ditch has disappeared and water flows down the footpath before joining the ditch on the other side of the fence. The ditch should be reinstated in line with this culvert.
- The culvert inlet should have a headwall to protect it and downstream from any flood surges
- Consideration should be given to the use of a trash screen to prevent blockages from vegetation etc
- Although a headwall will offer some protection; the upstream attenuation recommendations such as soakaways at the B4507; flow control within ditch and infiltration basin will provide a stable long term benefit and reduce the risk of flooding downstream.

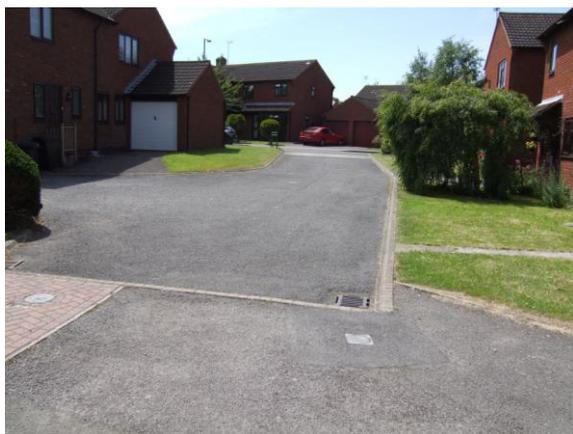
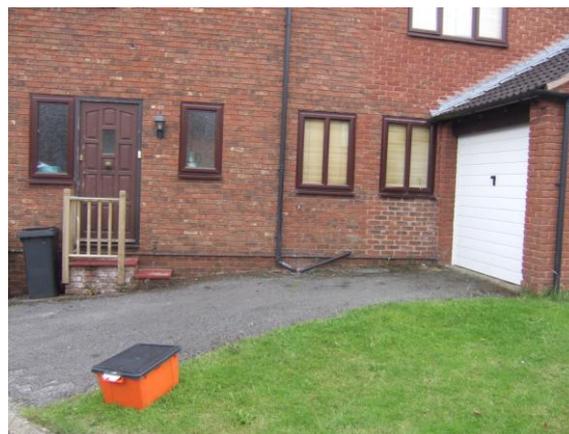
Photo 3.28: Kimbers Field; view looking upstream towards Avenell Road. No's 3, 4 and 5 are potentially susceptible to surcharging sewers and overland flows generated upstream. In the foreground is the highway gully adjacent to No.3, prone to surcharging. A short-term cost-effective solution option would be to install a ring soakaway in the road between the gullies (SBC). Photo 3.29: shows the property with an improper connection into the surface water sewer, which is considered to cause the surcharging foamy water from the gully adjacent to No. 4.

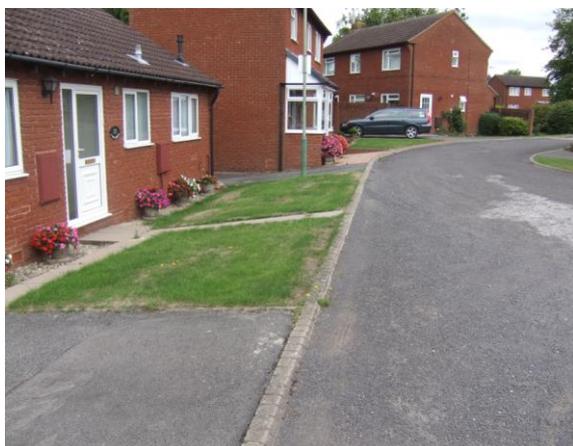
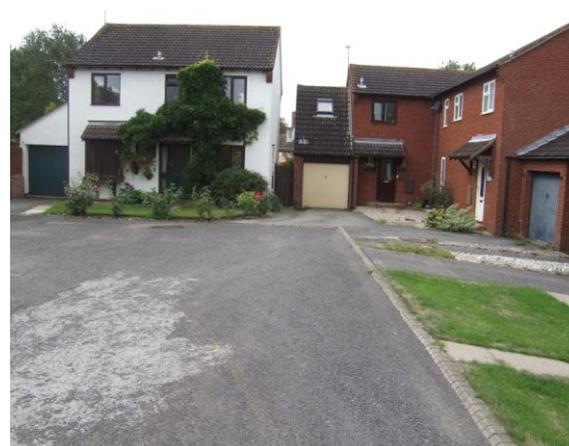
Photo 3.30: The Hedges looking upstream towards Magdalen Road shows the properties below the road surface level therefore potentially susceptible to surcharging sewers and overland flows generated upstream, as with Kimbers Field. Potential options to reduce the risk of flooding are to introduce ACO drains to pick up overland flows and discharge into soakaways. Photo 3.31: looking downstream at lower section of The Hedges; highway gullies here experience same problem as Kimbers Field and potential solution is to soakaways into road.

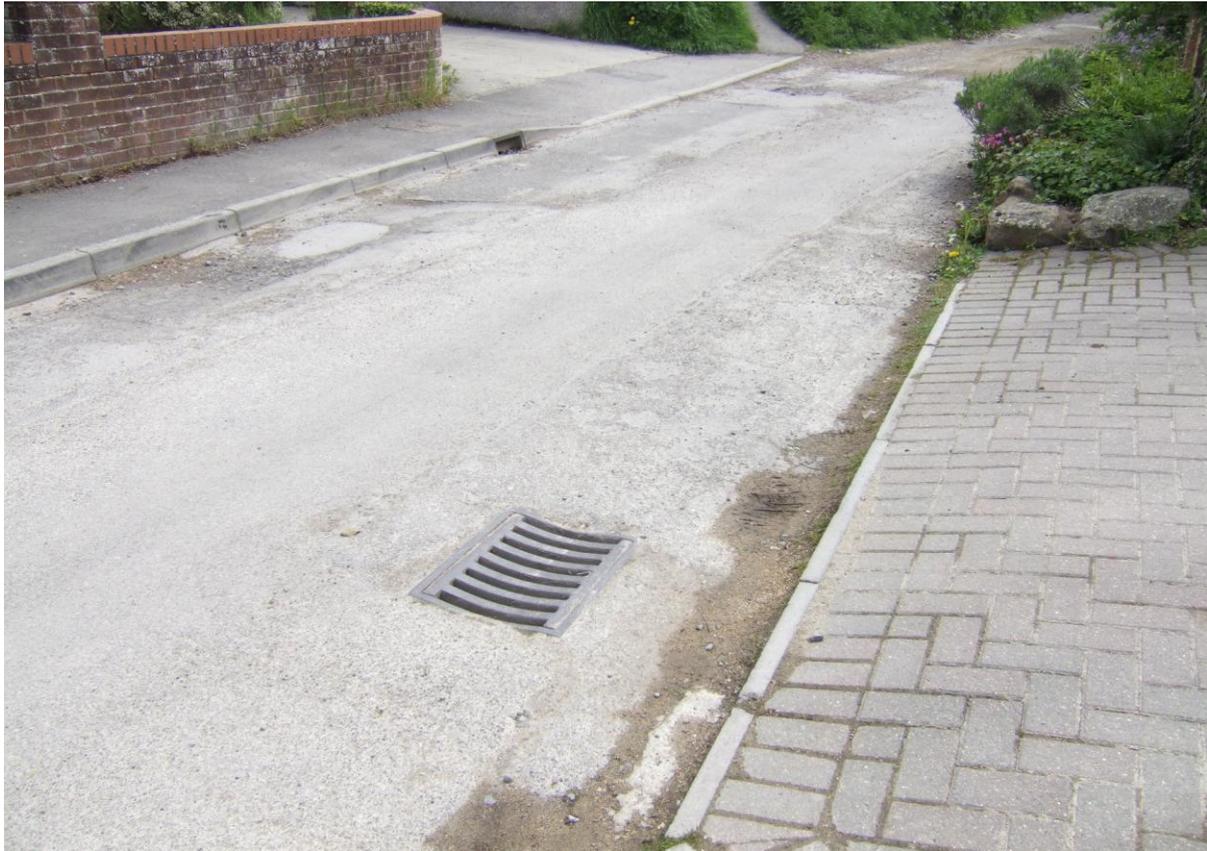
Photo 3.34: Looking upstream at the lower section of Chapel Lane; here the highway drain system is evident; an investigation can determine the extent of the drainage and whether it extends the full length of Chapel Lane. However, at this stage it is considered that this system starts here and discharges into the High Street system. If this is the case then the gullies shown in the photo would struggle to pick-up the surcharging water flowing down the hill, due to their size and location.

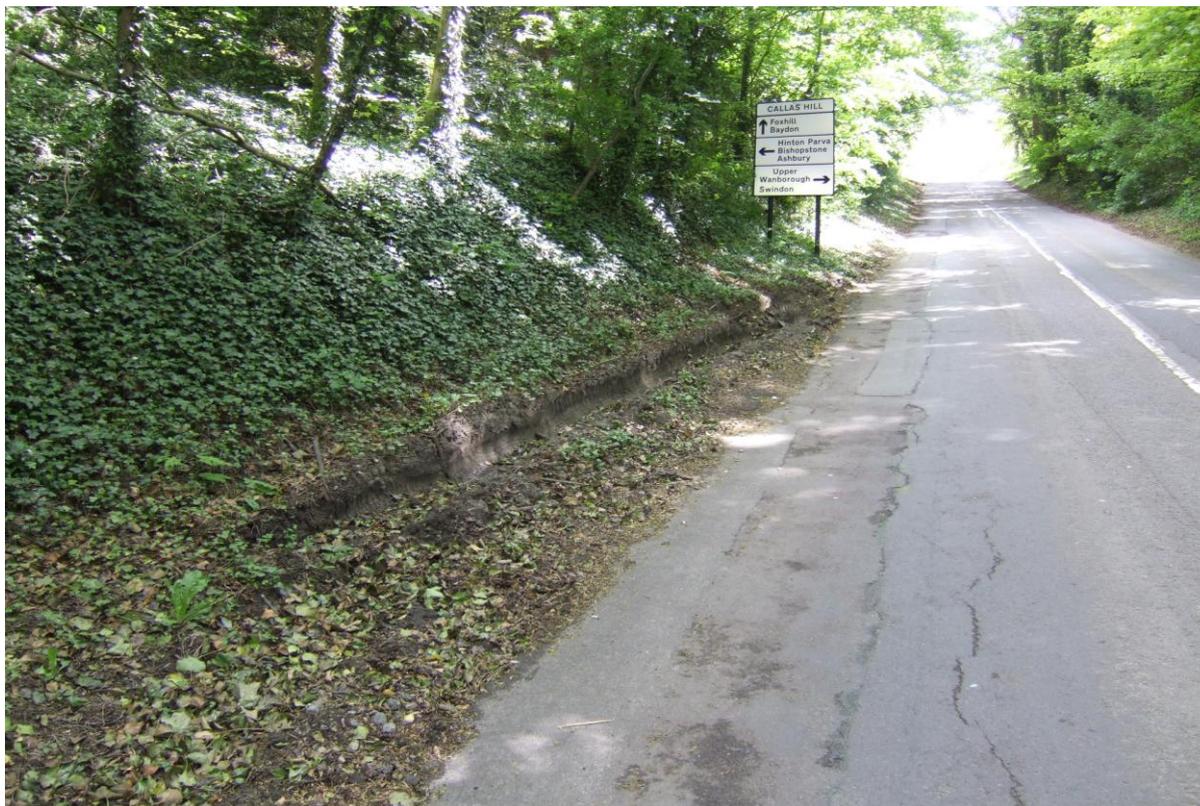
Photo 3.35: view looking south-east close to top of High Street/ Callas Hill. Looks as though this area has been used for parking by a heavy vehicle; shows the vulnerability of the embankment due to wetness. This maybe a good location to introduce a soakaway, or extend existing drainage system with protected gully (photo 3.40). Kerbs or retaining structure could also be considered here.

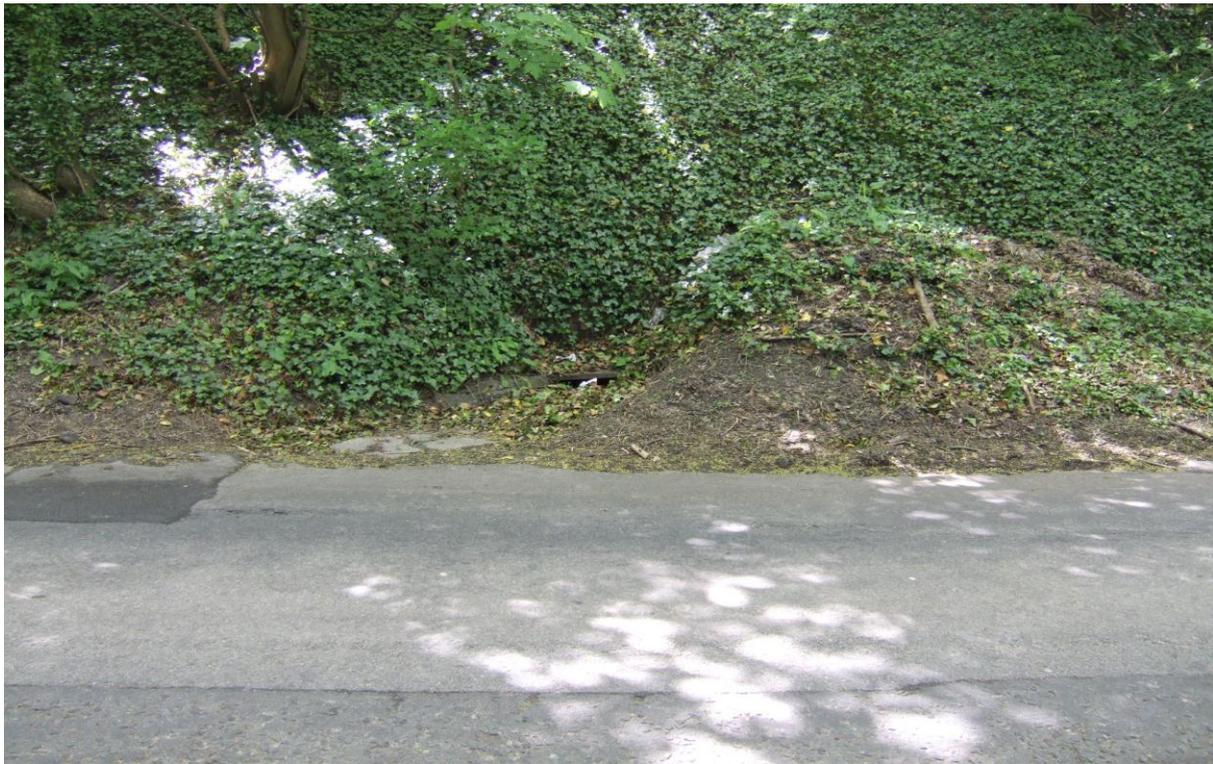
Photo 3.38: Collection point/ kerbside gully again susceptible to blockage with debris and vegetation from surrounding embankment.

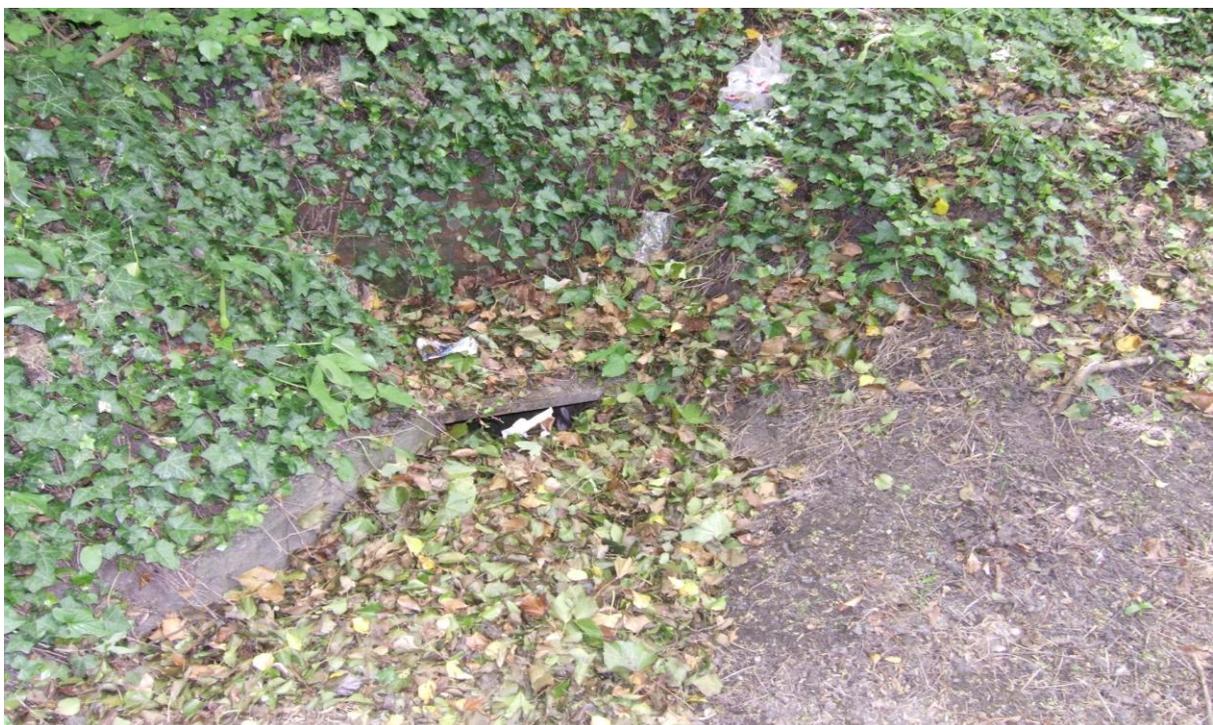
Photo 3.39: the same gully as above filling up with leaves; also evident here is road re-surfacing works are also gradually impeding the capacity of the gully as it sinks lower beneath the surface.

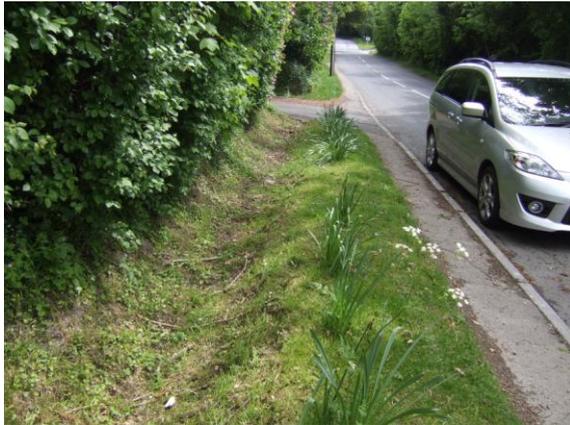
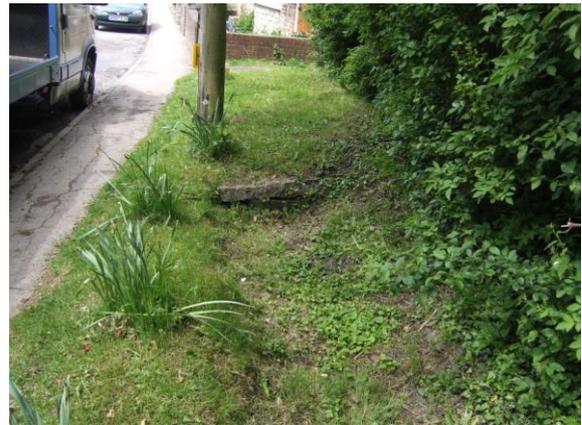
Photo 3.43: High Street east-side; the shallow ditch does not show much sign of being in use as a highway drain. It could be the time of year suggesting a winterbourne ditch, or water from the road not being able to reach the ditch due to amendments by landowner, or possibly replaced by a newer system in the High Street (doubtful). Photo 3.44: shows intake at end of ditch which probably connects to piped highway drain in the High Street; all this section may require reinstating. However, it is recommended to have the whole system flushed CCTV'd and mapped.

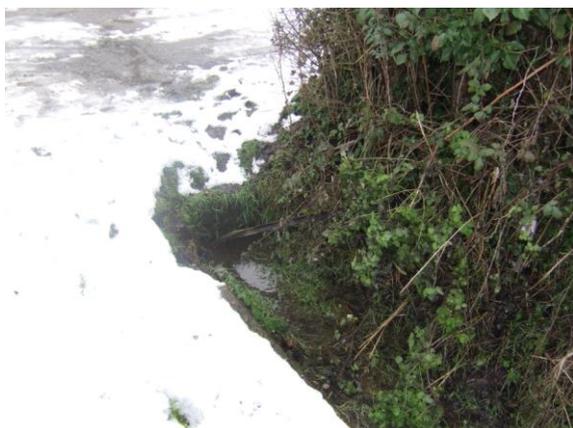
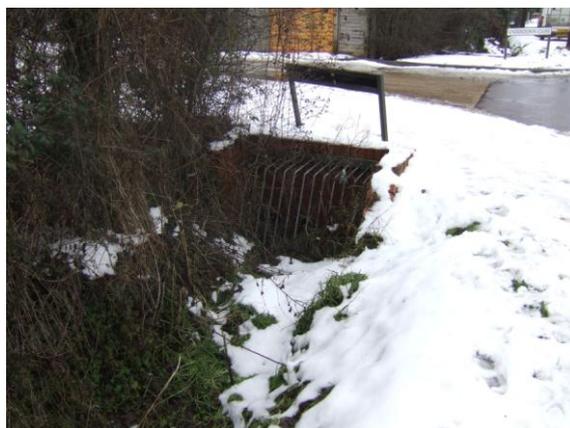
Photo 3.49 and 3.50: the lower section of Kite Hill comprises open ditch on both sides of the road; the photos above show a couple of culverted access points within the west ditch. Photo 3.49 restricts flows as it requires ditch clearing. Photo 3.50, shows either a poorly designed culvert or a culvert designed to hold back (attenuate) flows with very small pipes and a headwall; a possible solution for Springlines and other parts of the village drainage system but here can only cause risk of flooding to adjacent properties.

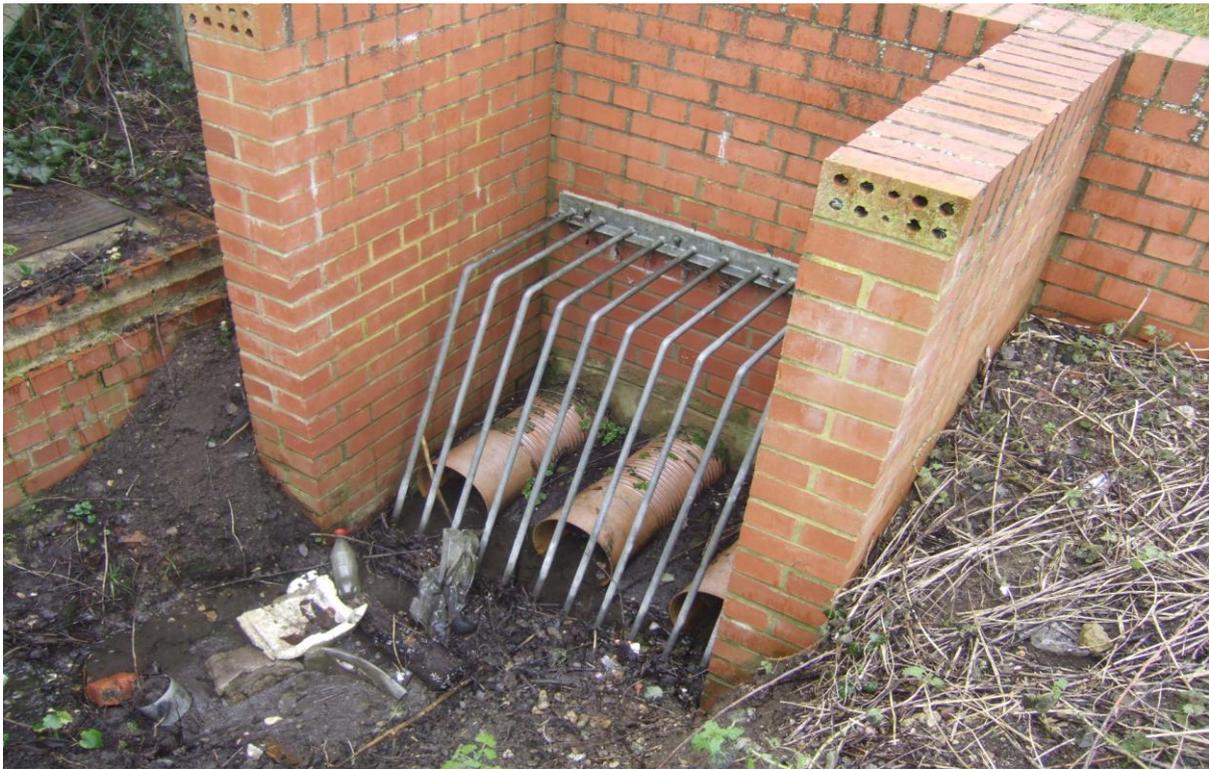
Photo 3.51: At the foot of the open ditch on the west side of Kite Hill is the structure shown above. This is considered to be purpose built to hold up flows. However, the purpose for this is unclear as there is no property at risk downstream of this, from here the water is discharged into Green Lane, which is considered to be a better location for attenuation. Holding back flow at this location and indeed the locations shown in Photo 3.50 and 3.52 increases the risk of flooding to adjacent properties.

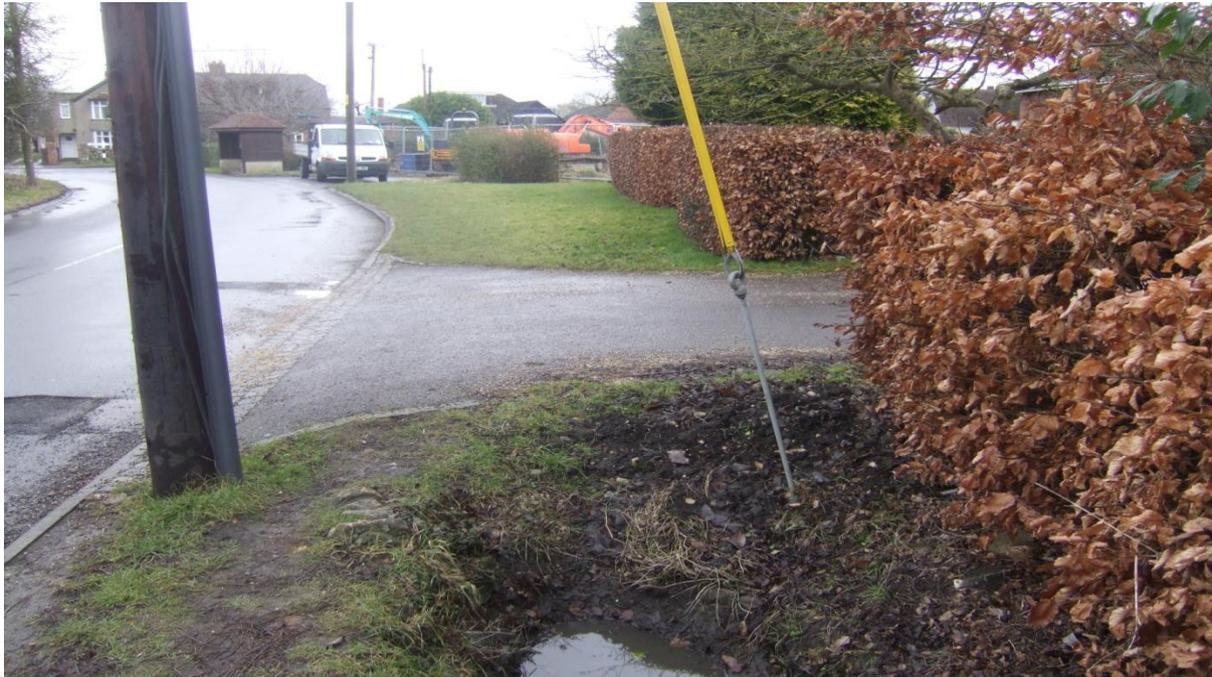
Photo 3.56: Ditch on south side of Rotten Row aligning with Pond House/Wessex House properties; outlet beneath access road is missing. Ditch should connect to highway drain discharging east towards High Street, suggesting there should be a piped or culverted section from this point to the garage; or ditch on the side of road.

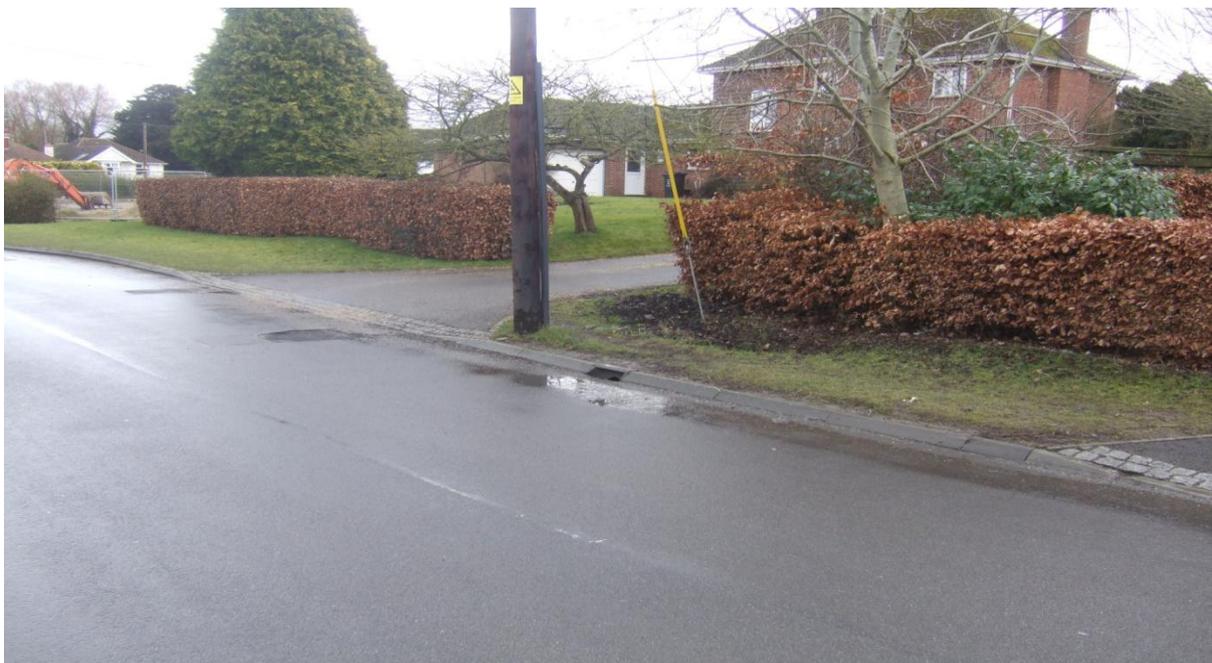
Photo 3.57: Remnants of old ditch system bordering Glenville/ Pond House area; possibly lost during development. Kerb- gully pot suggests it now forms part of the highway drainage, linking south side of road to the High Street, past the garage.

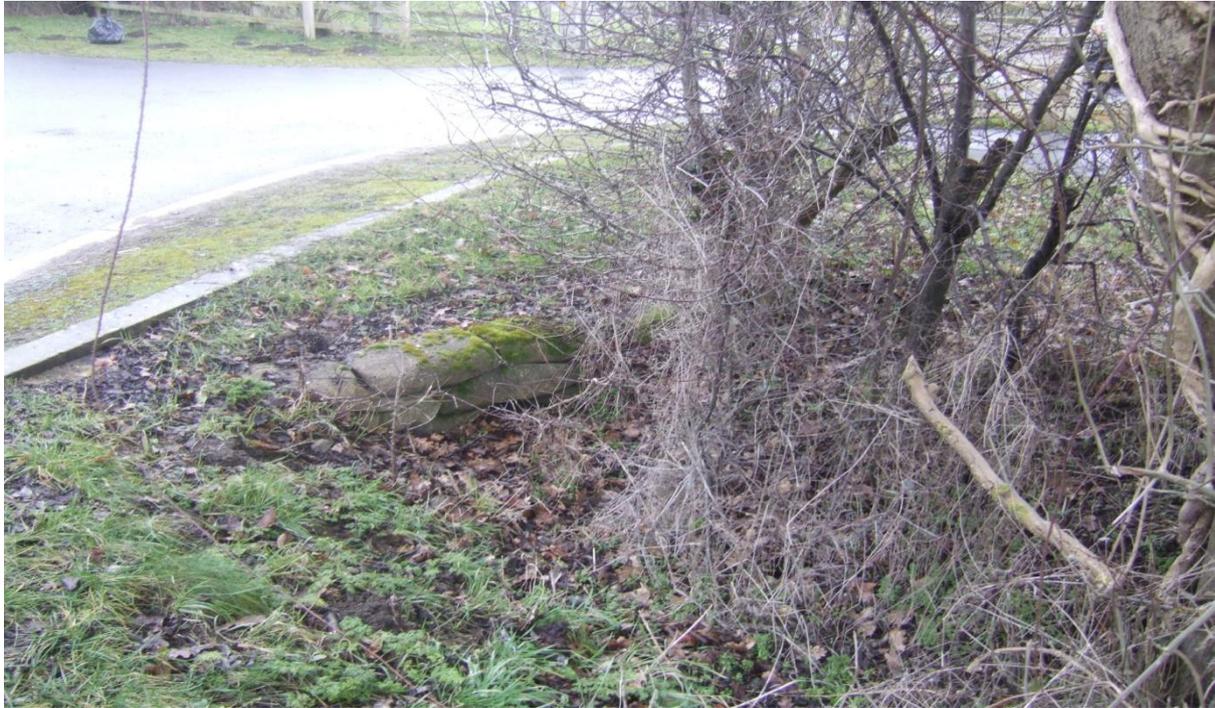
Photo 3.58: culvert beneath access road into Hooper's Field requires flushing

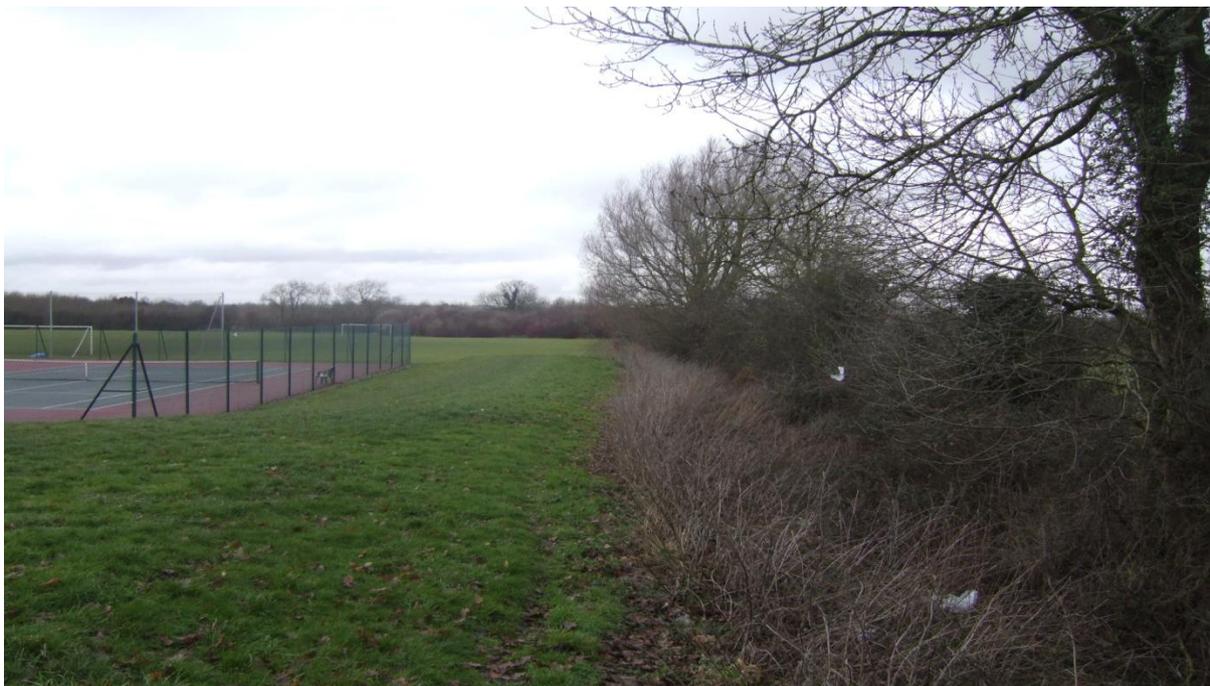
Photo 3.59: Ditch on eastern boundary of Hooper's Field flows northwards and discharges into Burycroft. Ditch forms part of the highway drain system collecting water from Rotten Row and some from the connecting drains in Kite Hill. Ditch requires improvements but it should be noted that this section of ditch can provide some storage during extreme rainfall events due to its depth and location.

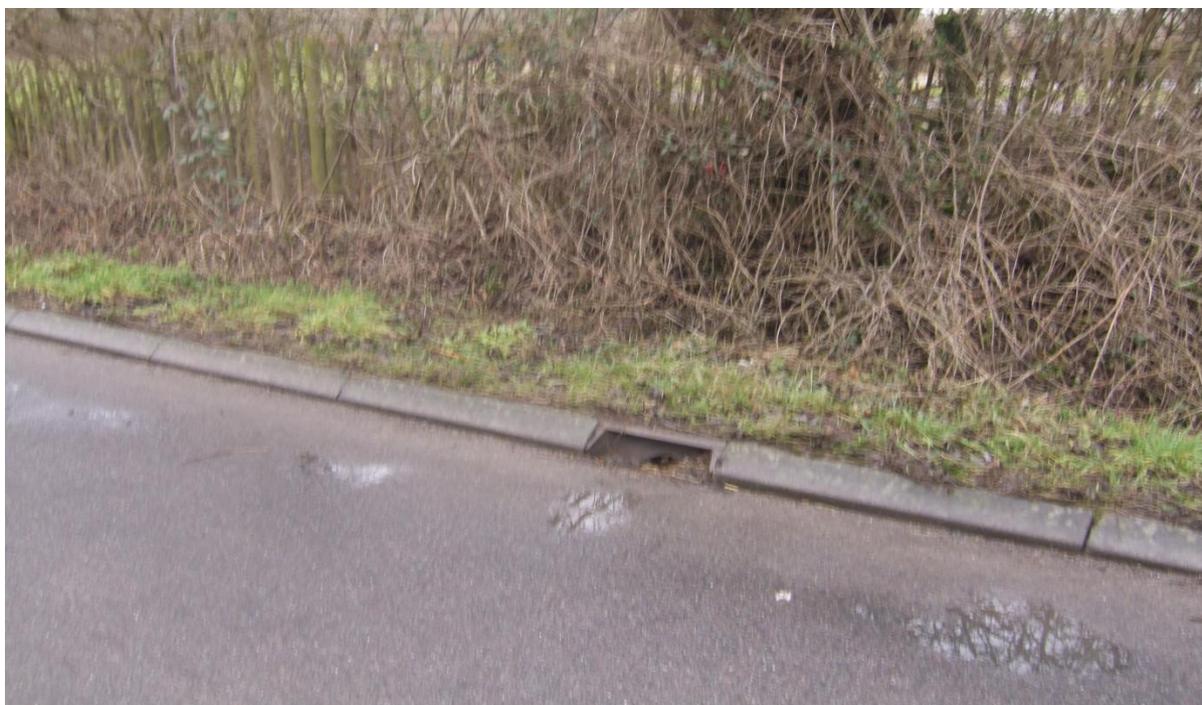
Photo 3.60: Kerb gully-pots are broken or blocked in Rotten Row and require clearing or replacing

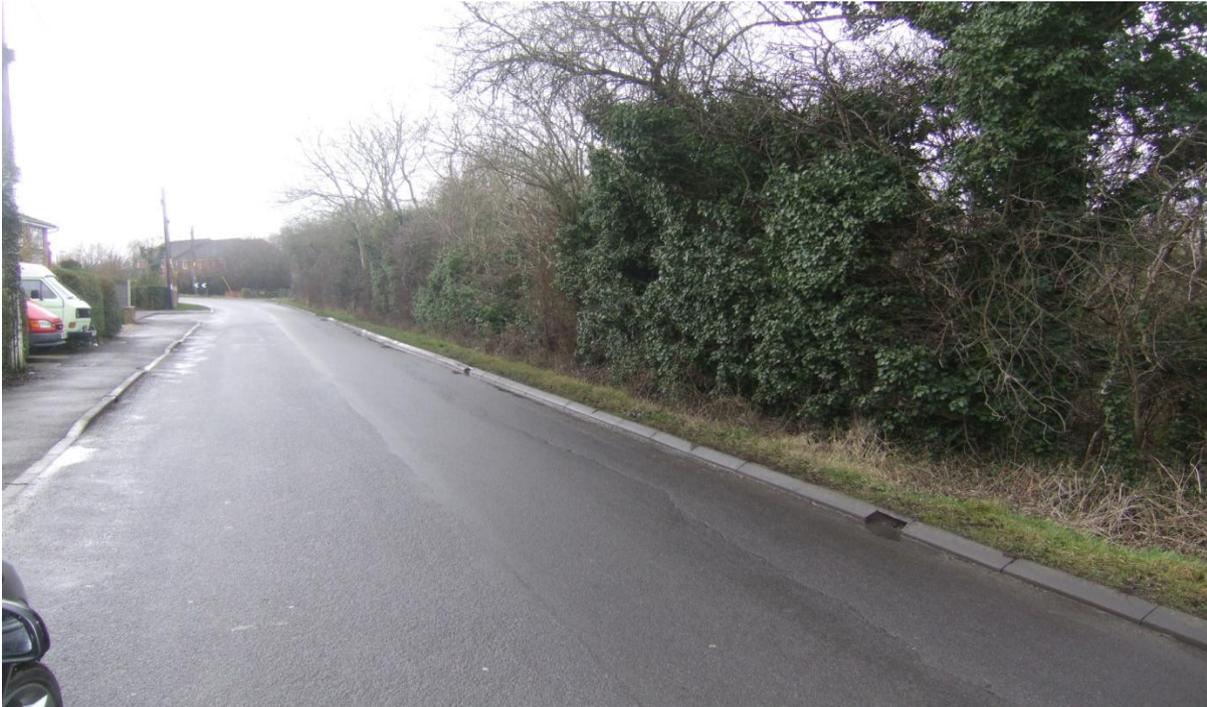
Photo 3.61: ditch flows eastwards towards Hooper's Field forms part of highway drainage and requires attention along with gully pots

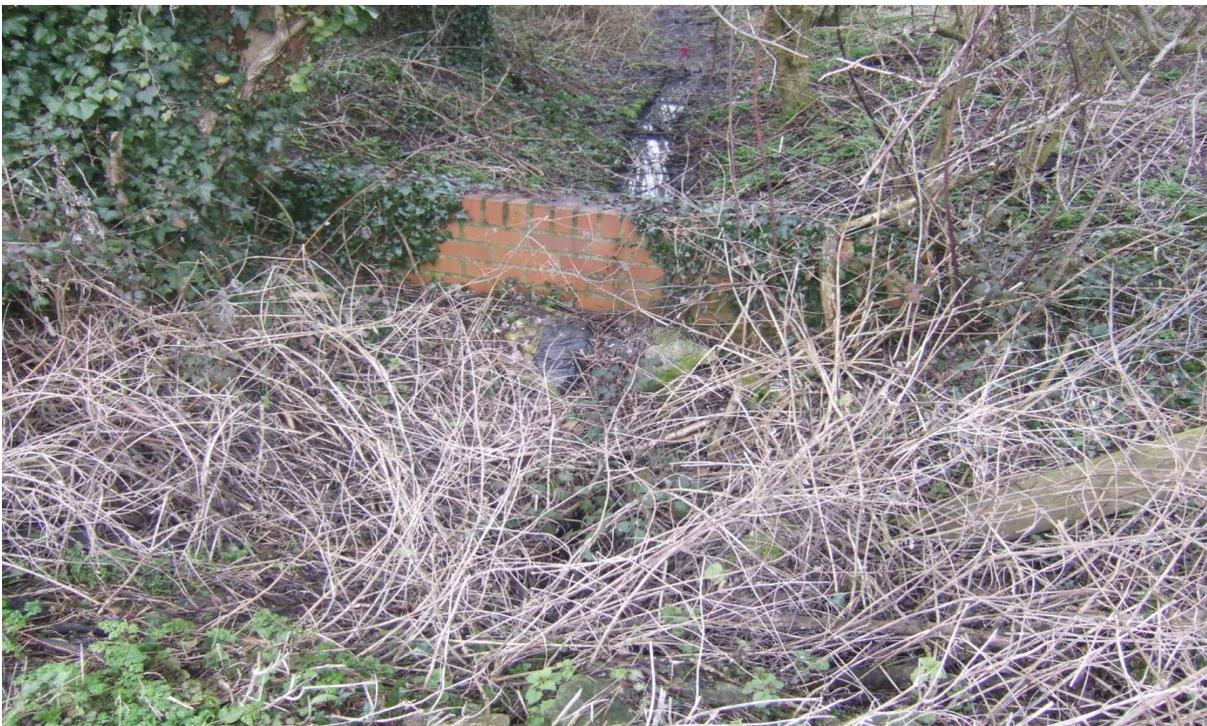
Photo 3.62: culvert and headwall discharging into woodland currently owned by Woodlands Trust; ditch on the downstream side requires digging/improvements – (another potential area for

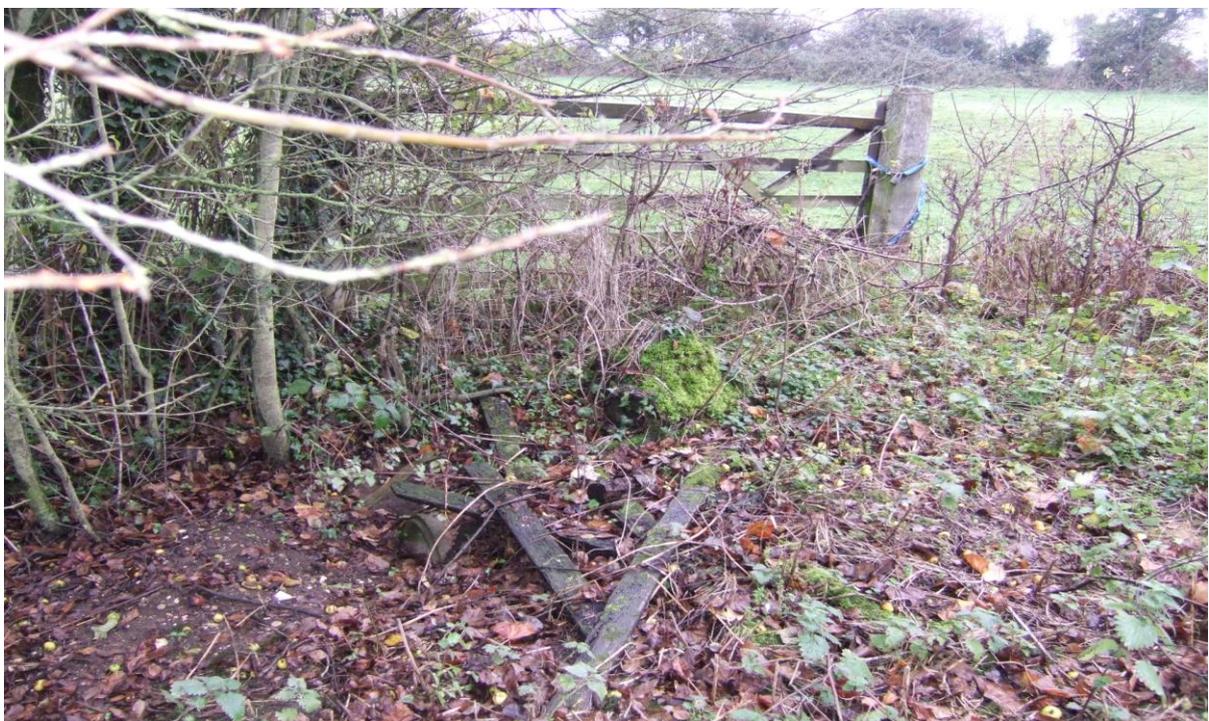
Photo-3.75: Disused access to field; should have small culvert and ditch either side should be reinstated

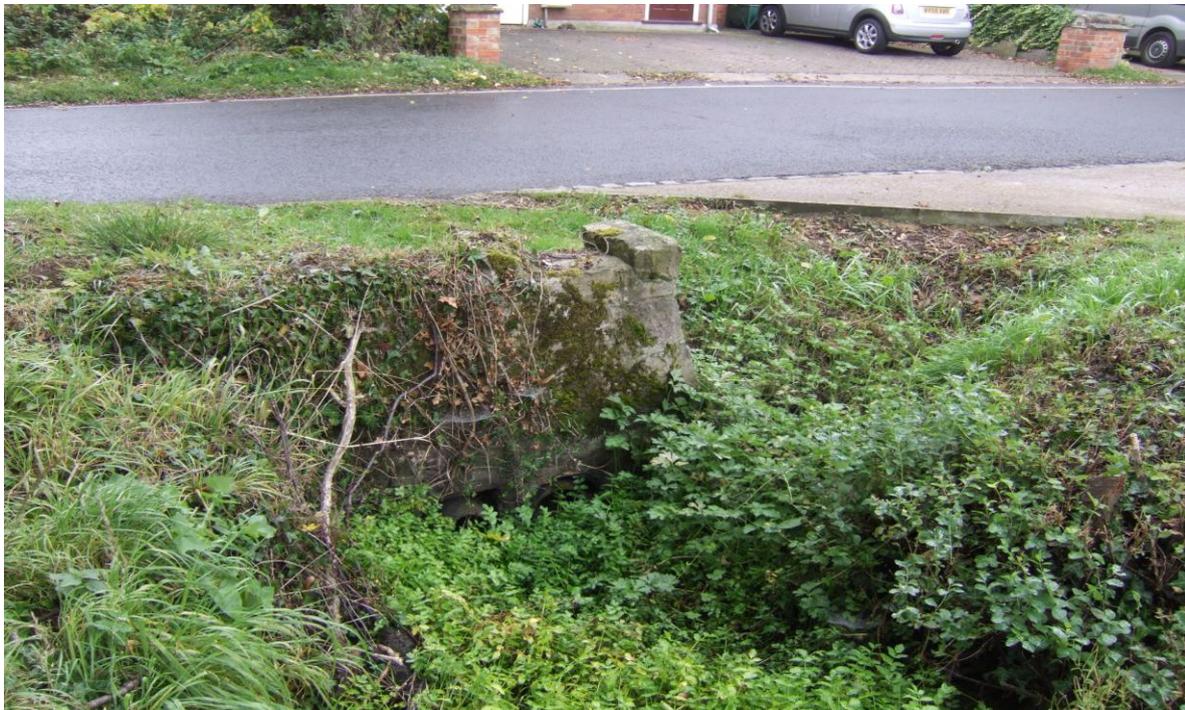
Photo-3.77: View southwards at land drain culvert outlet beneath The Marsh road. The culvert requires attention; increasing the capacity of the culvert by resizing may be an option to reduce risk of flooding

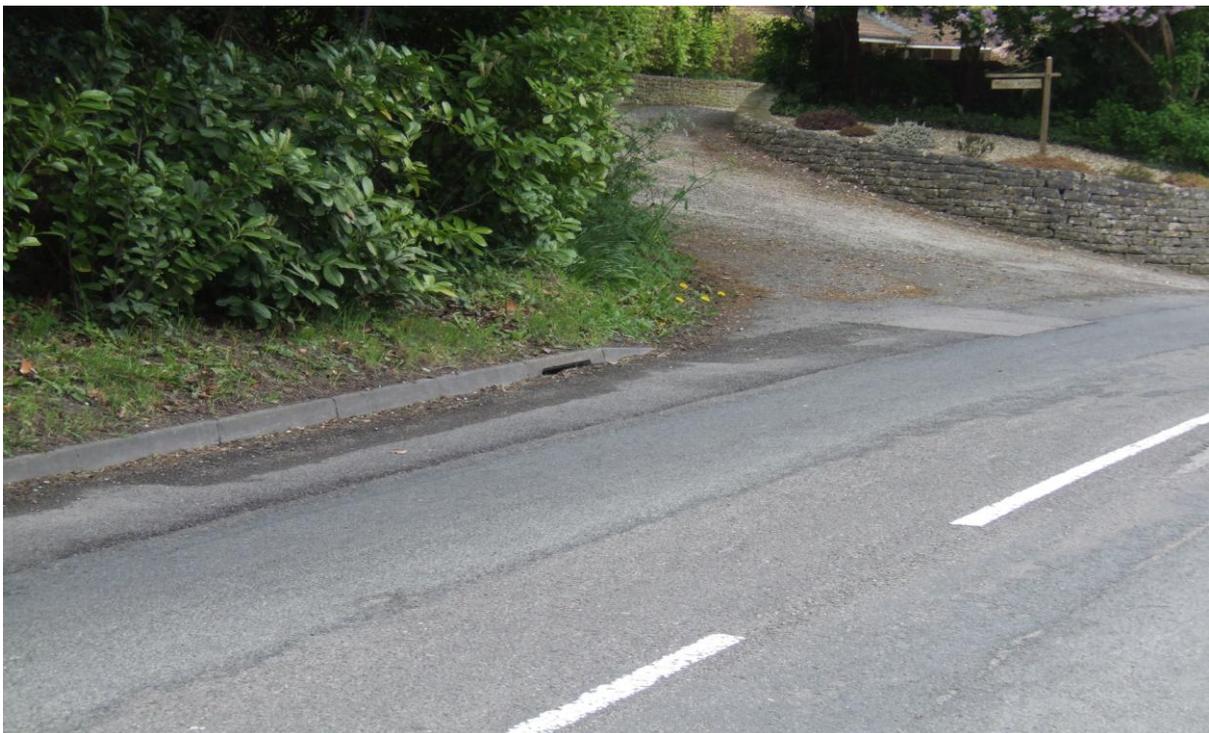
Photo 3.79: sunken kerb gullies caused by resurfacing of road; this allows surface water to bypass the gully and continue to flow down road. As this water gathers momentum down the hill it is unlikely to get picked up by the next gully and so on until it reaches the lowest point and then ponds and floods the road and/or adjacent properties.

Replace damaged/ sunken kerb gullies
