WANBOROUGH FLOOD AND DRAINAGE MANAGEMENT REPORT

Wanborough, Swindon, Wiltshire

Revised Report: February 2011

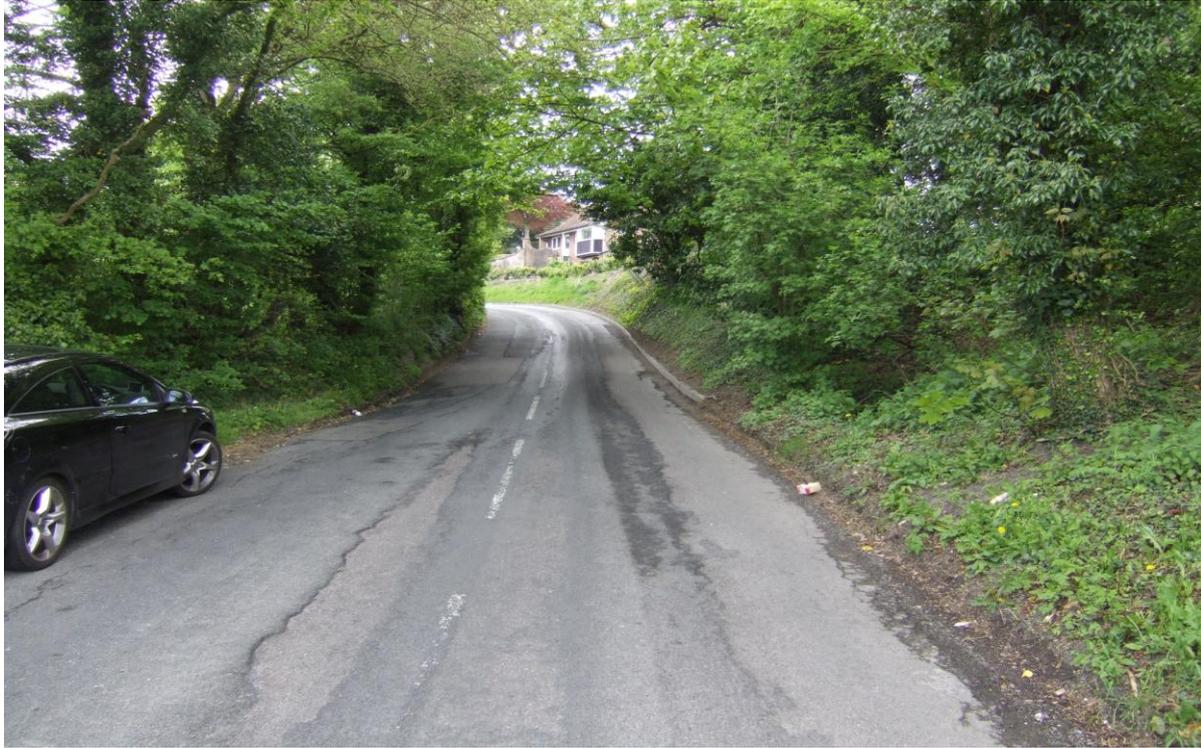
Photo 3.80: high sided banks either side of the road allows debris and vegetation to get washed down and block gullies.

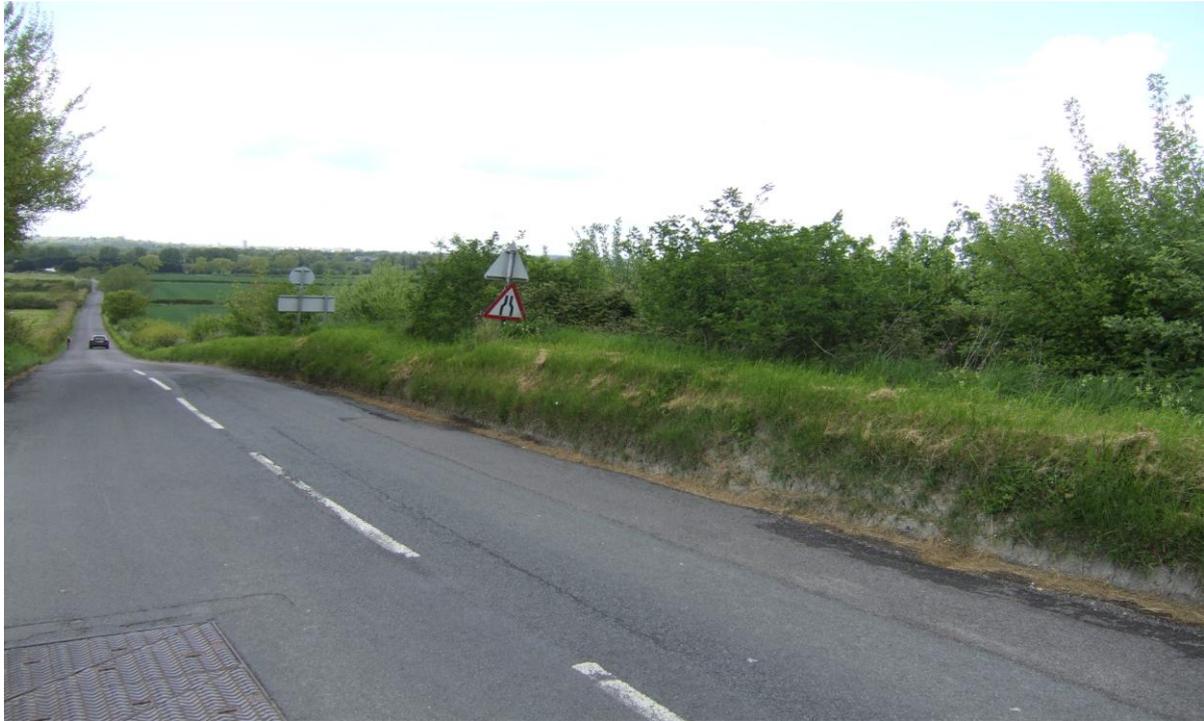
Photo-3.81: View west down Pack Hill; undersized and lack of gullies along the upper section of road; allowing road to be used as a conduit.

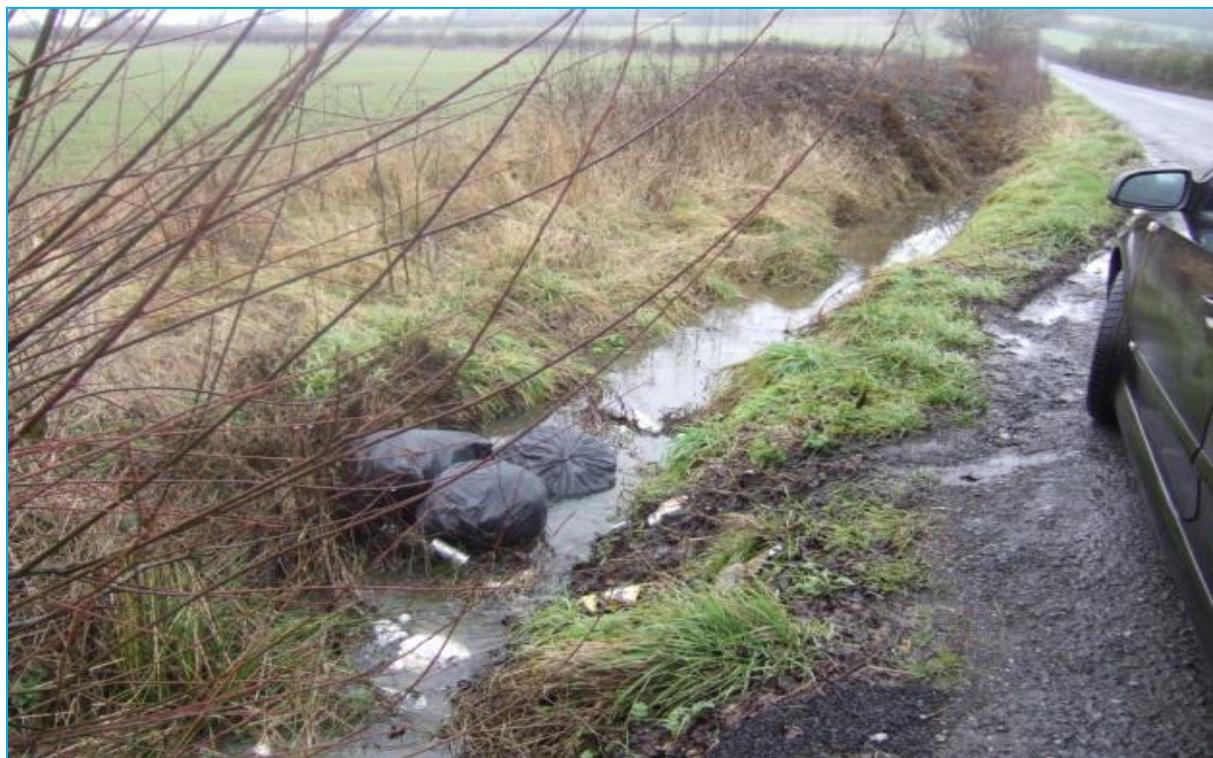
Photo-3.82 Roadside ditch down Pack Hill (north), now diverted northwards (see Appendix B). Fly-tipping is always a problem, regular maintenance will ensure the ditches remain clear and free-flowing.

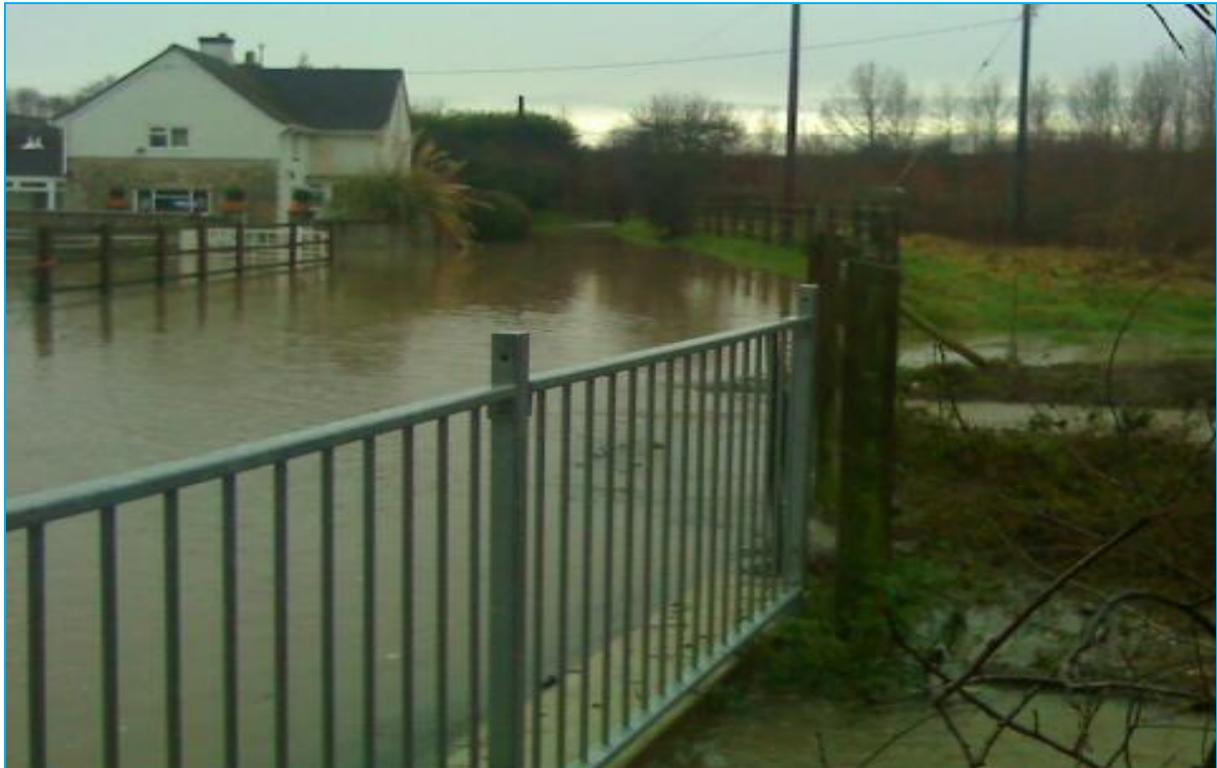
Photo 3.83 Flooding at Moorleaze House, Old Swindon Road in July 200

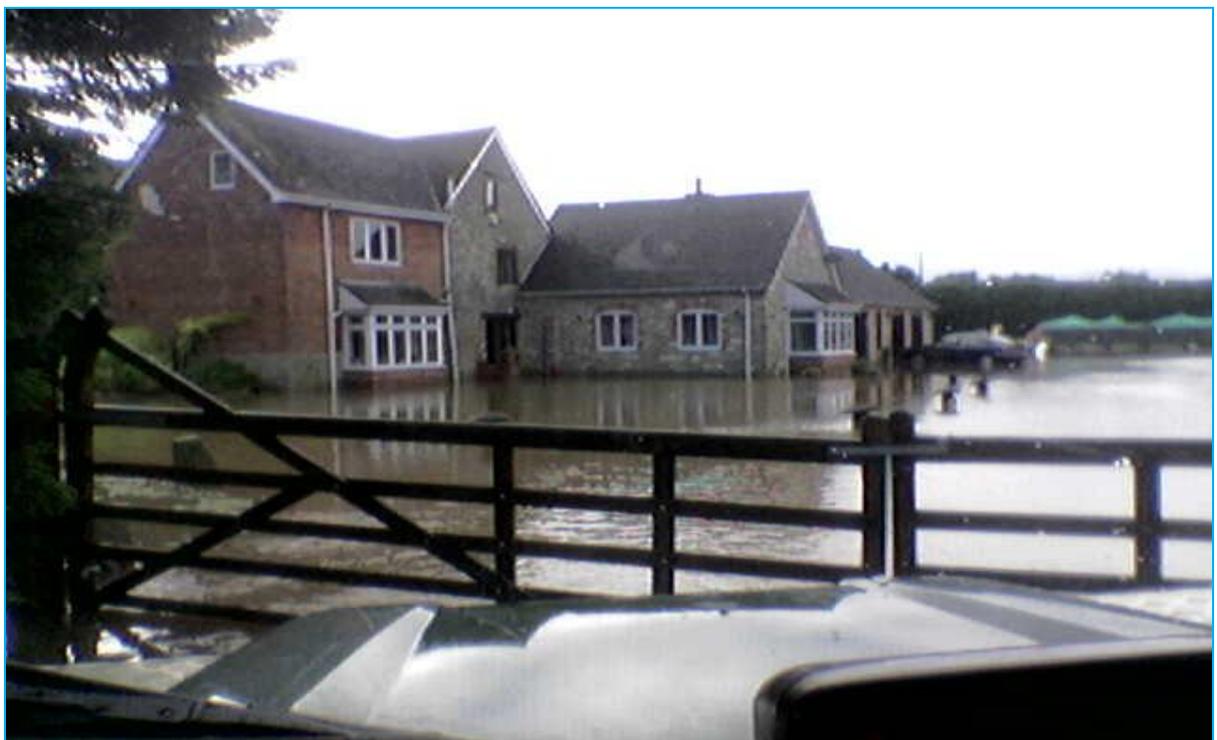
Photo 3.84: Flooding at Great Moorleaze Farm in July 2007

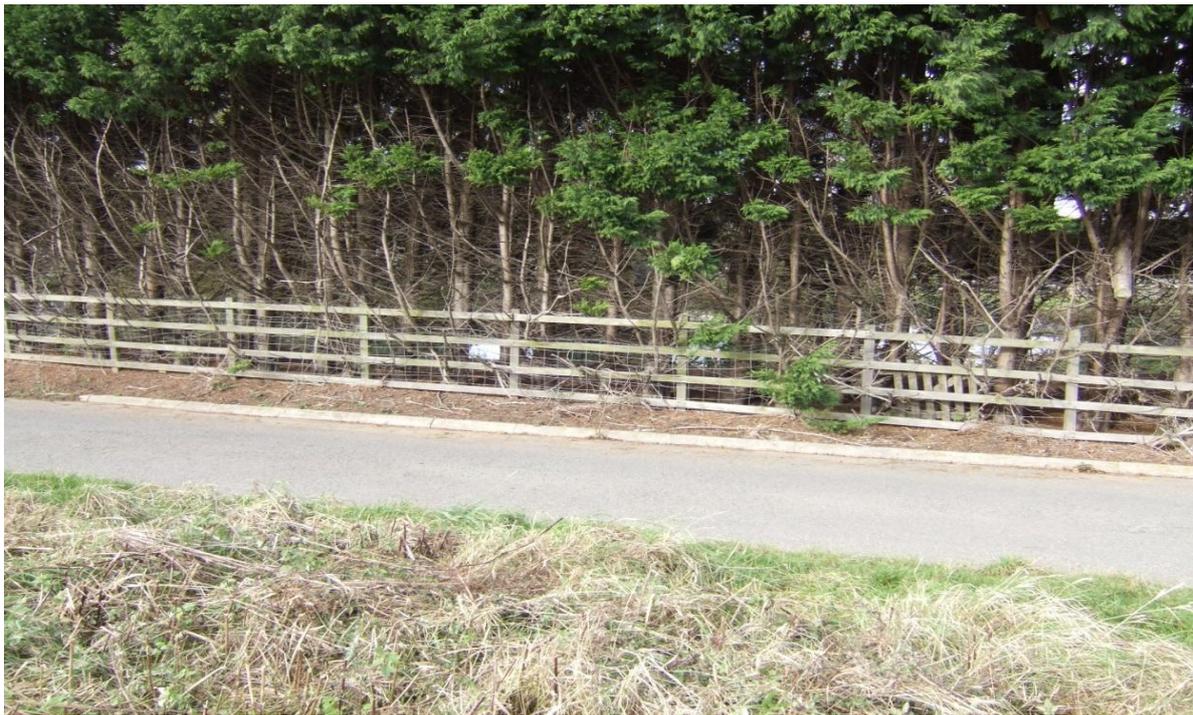
Photo 3.92. highway drain runs alongside south boundary fence of Great Moorleaze Farm; requires flushing, cctv and mapping

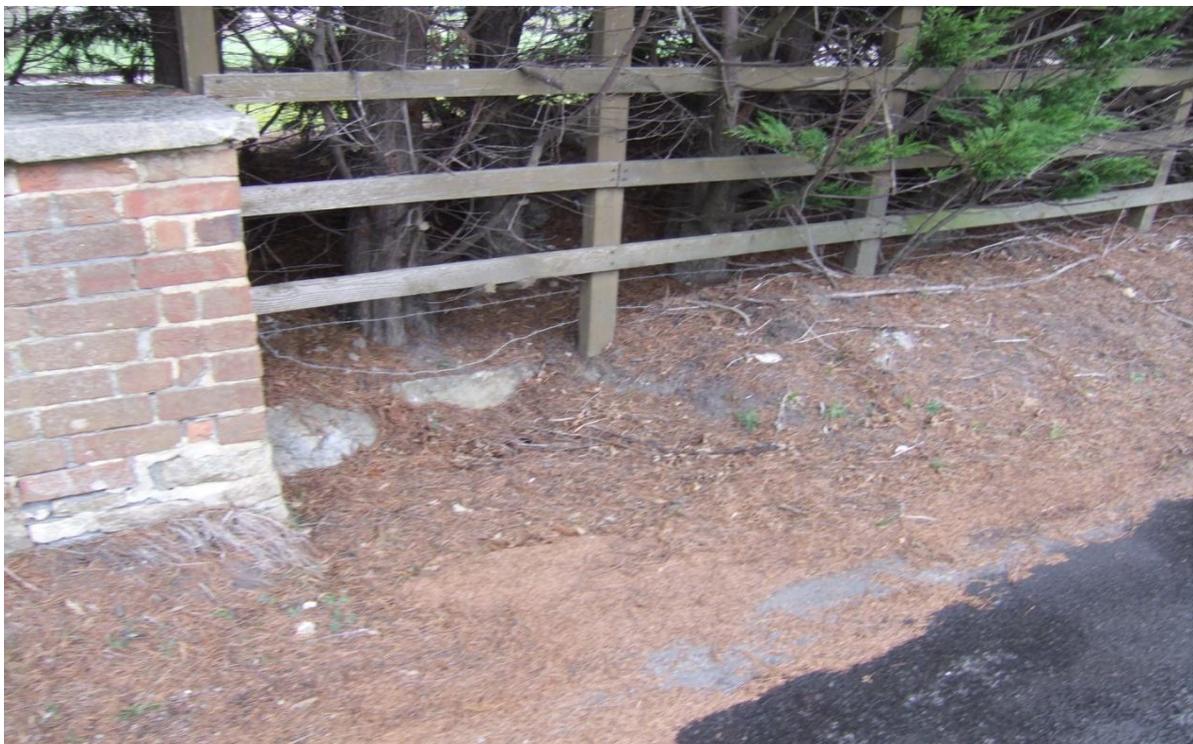
Photo 3.93. gully and pipe susceptible to blockage from falling vegetation and debris from overland flows
