Project Title Wanborough Flood Assessment	
Project Engineer Carl Collins	
Contact 07881 456610 01249 714321	
Approved by:	
Title: A3 view 5	
Revision: 2	
KEY	
Main River	
Land Drain	
Ditch	
Highways drainage	
Storage	
Water Course Improvement	
Properties with history of flooding	
Properties with high risk of flooding	
Run off from hills	
Overflowing drain

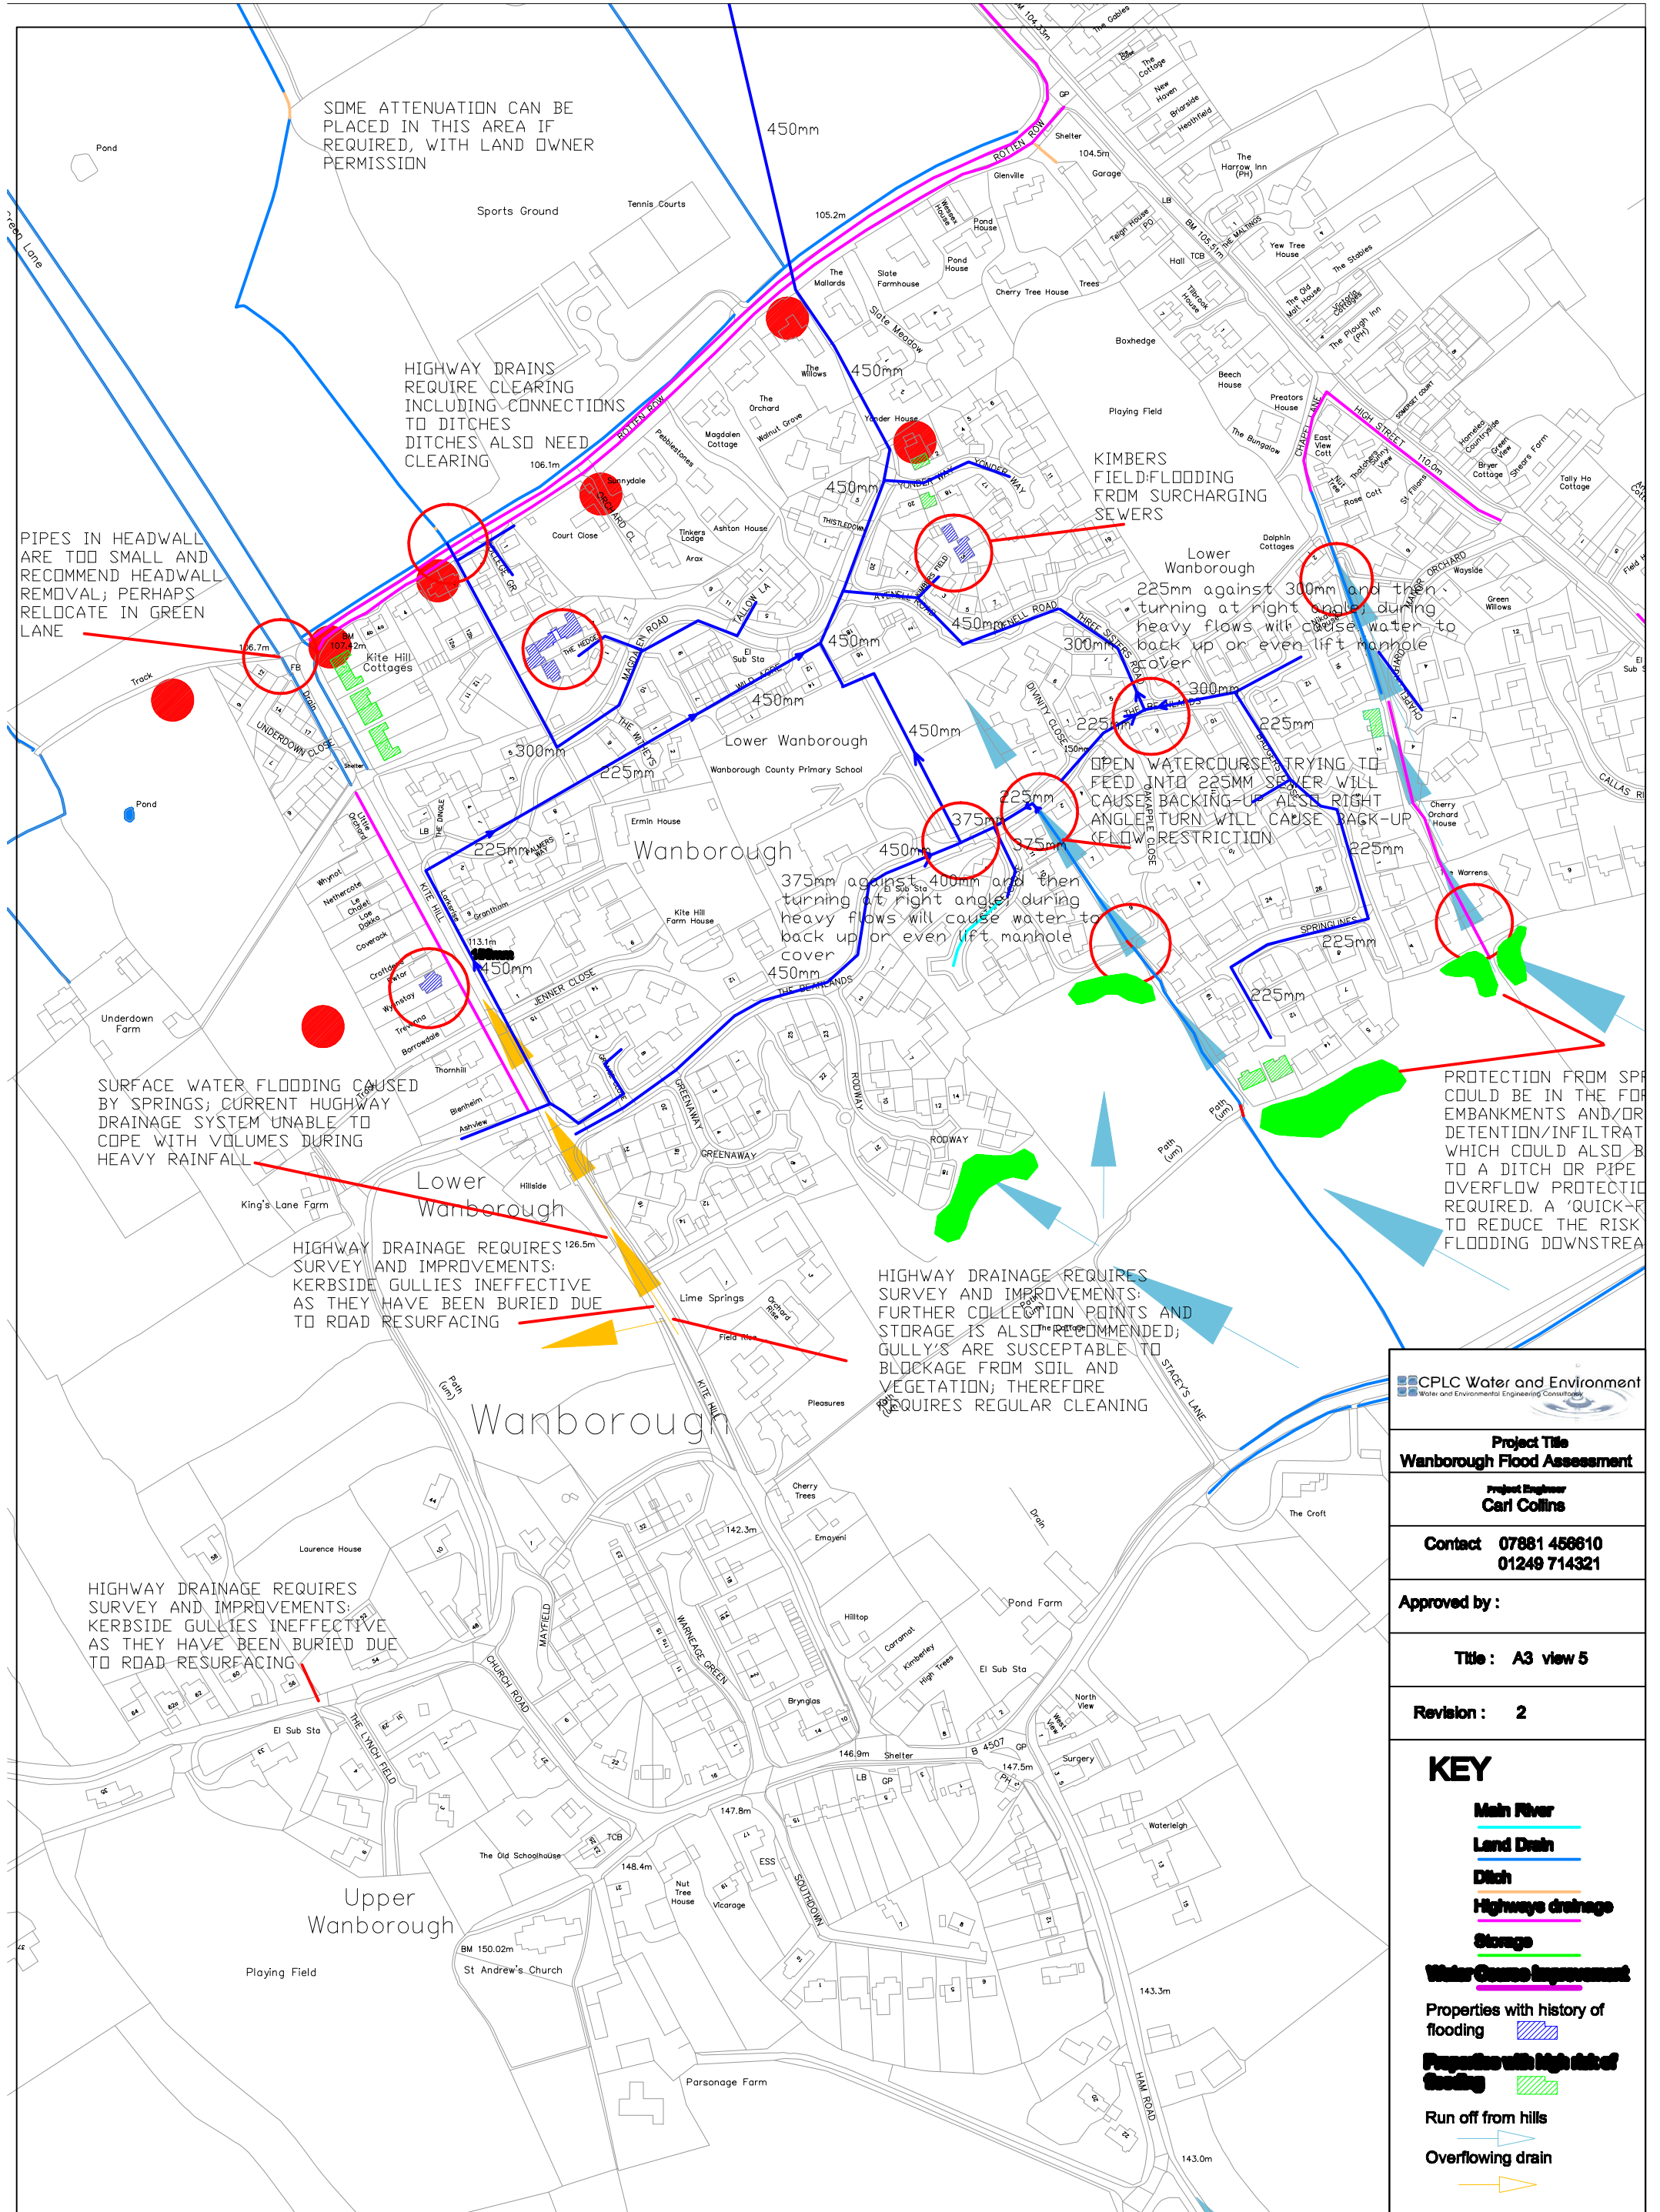
HIGHWAY DRAINS REQUIRE CLEARING INCLUDING CONNECTIONS TO DITCHES DITCHES ALSO NEED CLEARING

PIPES IN HEADWALL ARE TOO SMALL AND RECOMMEND HEADWALL REMOVAL; PERHAPS RELOCATE IN GREEN LANE

KIMBERS FIELD: FLOODING FROM SURCHARGING SEWERS

Lower Wanborough 225mm against 300mm and then turning at right angle during heavy flows will cause water to back up or even lift manhole cover

OPEN WATERCOURSE TRYING TO FEED INTO 225MM SEWER WILL CAUSE BACKING-UP ALSO RIGHT ANGLE TURN WILL CAUSE BACK-UP FLOW RESTRICTION

375mm against 400mm and then turning at right angle during heavy flows will cause water to back up or even lift manhole cover

SURFACE WATER FLOODING CAUSED BY SPRINGS; CURRENT HIGWAY DRAINAGE SYSTEM UNABLE TO COPE WITH VOLUMES DURING HEAVY RAINFALL

HIGHWAY DRAINAGE REQUIRES SURVEY AND IMPROVEMENTS: KERBSIDE GULLIES INEFFECTIVE AS THEY HAVE BEEN BURIED DUE TO ROAD RESURFACING

HIGHWAY DRAINAGE REQUIRES SURVEY AND IMPROVEMENTS: FURTHER COLLECTION POINTS AND STORAGE IS ALSO RECOMMENDED; GULLIES ARE SUSCEPTIBLE TO BLOCKAGE FROM SOIL AND VEGETATION; THEREFORE REQUIRES REGULAR CLEANING

SOME ATTENUATION CAN BE PLACED IN THIS AREA IF REQUIRED, WITH LAND OWNER PERMISSION

PROTECTION FROM SPRINGS COULD BE IN THE FORM OF EMBANKMENTS AND/OR DETENTION/INFILTRATION WHICH COULD ALSO BE TO A DITCH OR PIPE OVERFLOW PROTECTION REQUIRED. A 'QUICK-RELEASE' TO REDUCE THE RISK OF FLOODING DOWNSTREAM
