WANBOROUGH FLOOD AND DRAINAGE MANAGEMENT REPORT

Wanborough, Swindon, Wiltshire

Revised Report: February 2011

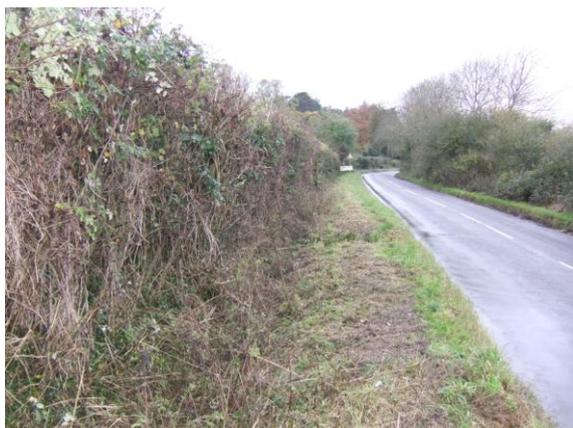
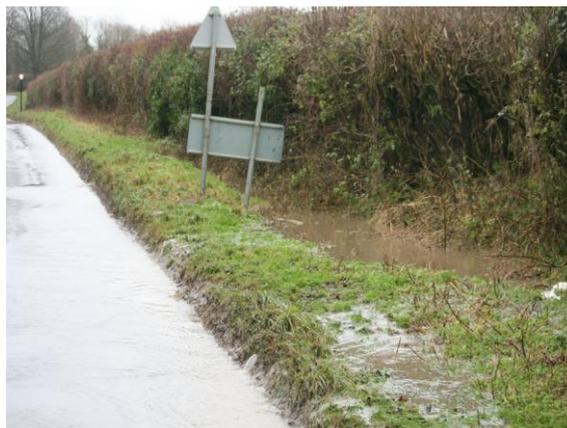
Photo 3.3: Ditch is overgrown and not deep enough; could be resized to pick up overland flows from springs on the higher ground to the south east. Photo 3.4 (supplied by WPC): Following heavy rainfall in 2007, it is clear the ditches here did not have the capacity to contain the overland flows a lot of which was generated by springs on the higher ground. This creates a two-fold problem as the water on the road cannot discharge into the ditch and overflowing water from the ditch pours onto the road. Current location of outfalls from this ditch is not known as yet (Nick Smith, SBC); however, it is considered the ditch is connected to ditches on adjacent side of road via culverts; this requires further investigation.

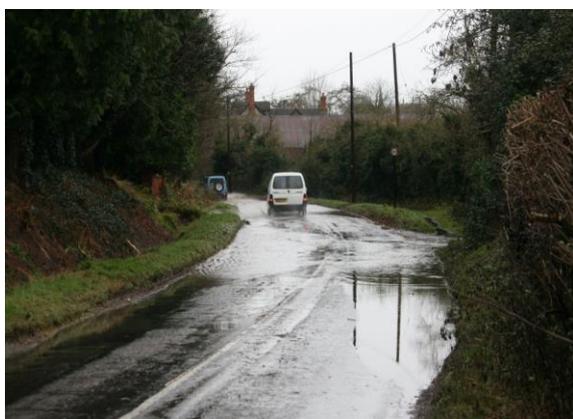
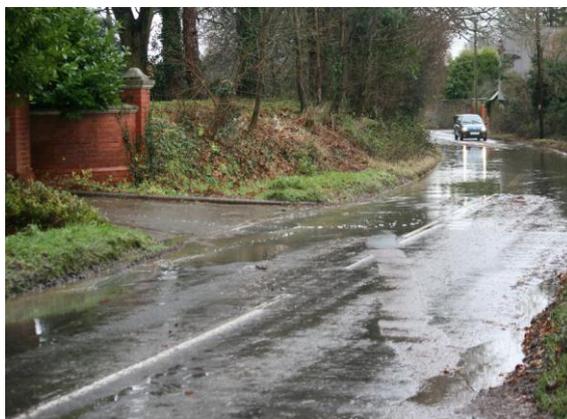
Photo 3.5 and 3.6 above (supplied by WPC): Shows the ditch either side of the driveway to The Croft is empty and water on the road. This would suggest that the ditch does not connect with the ditch further along this road and the lack of grips or gullies does not allow water to reach the ditch; also a restriction with the connecting culvert beneath driveway.

This area also requires further investigation to determine outfall location.

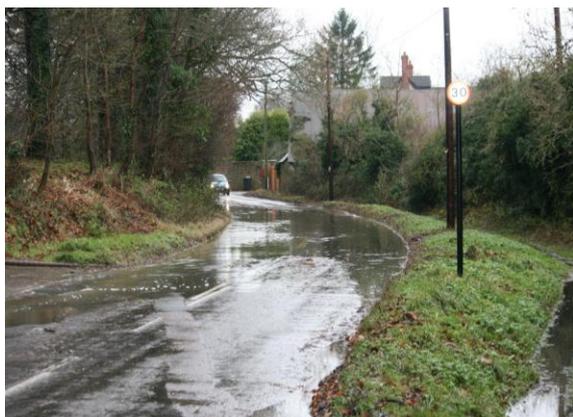
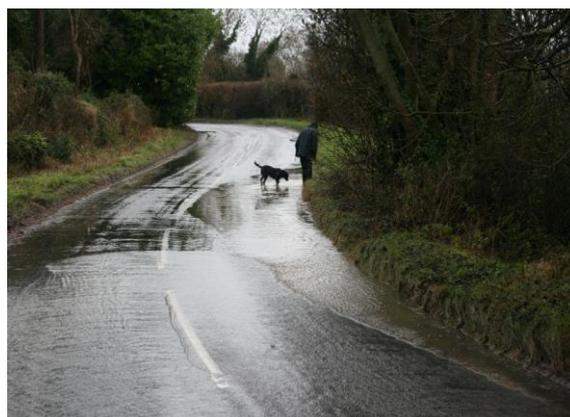
Photo 3.7 and 3.8 supplied by WPC): Shows points on the road (B4507) where water seems to collect (ponding) during heavy rainfall events. This is ideal for pinpointing areas to locate grips or indeed gullies; but as discussed briefly earlier the connecting ditches etc need to be cleared to allow water to discharge away; also along this section of road consideration could be given to the use of soakaways with overflows to connecting ditches, which will assist in controlling heavy flows.

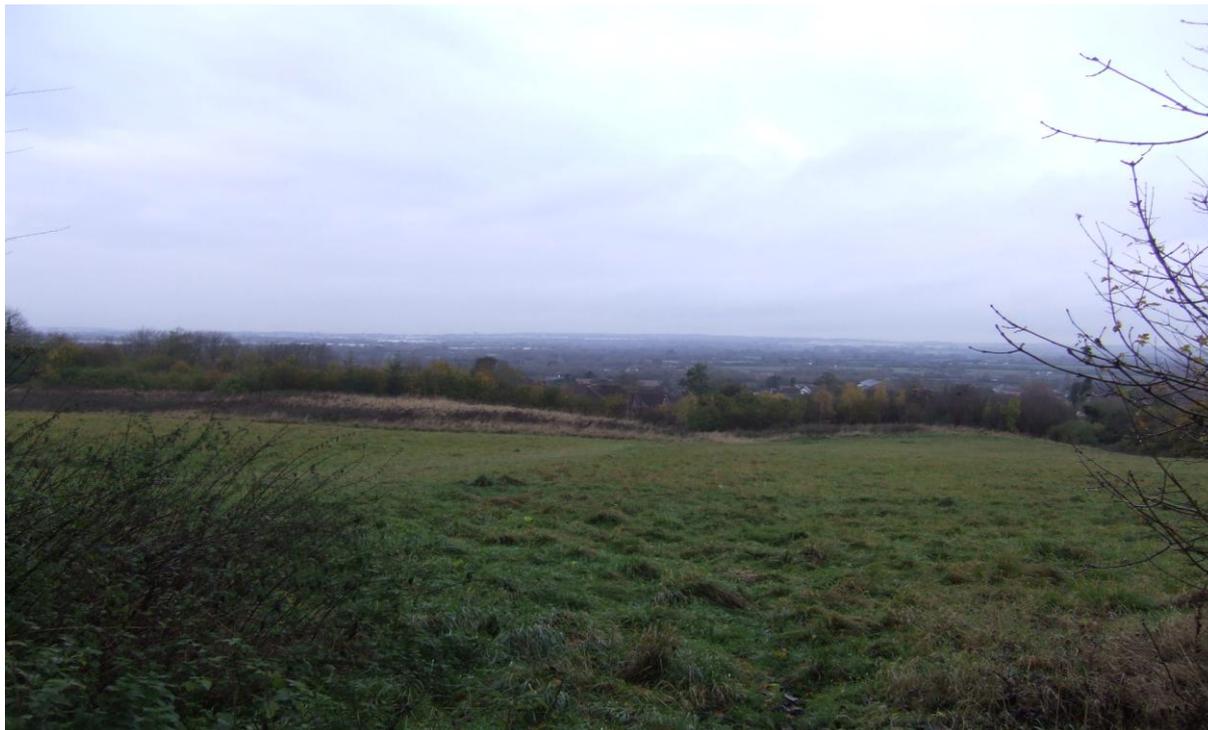
Photo 3.11: View of fields above Springlines facing north

The fields above Springlines not only act as a receptor for water generated in the hills above B4507, but also generate flows from springs. Generally, the flow paths are located on the east side, the middle and the western edge of the field when looking at the photo above. The tree line at the foot of the hill forms the boundary between the field and the residential housing area. In front of the tree line is a raised embankment; possibly constructed by the developer in an attempt to protect the houses.

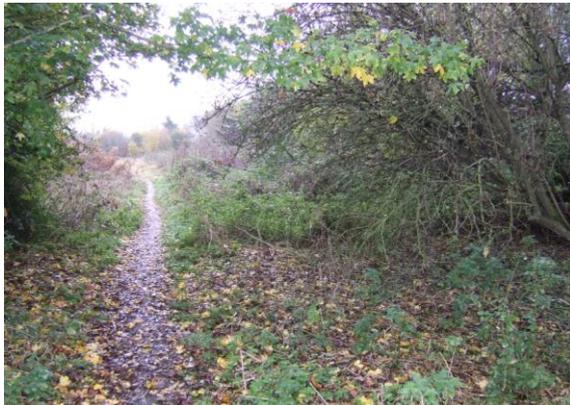
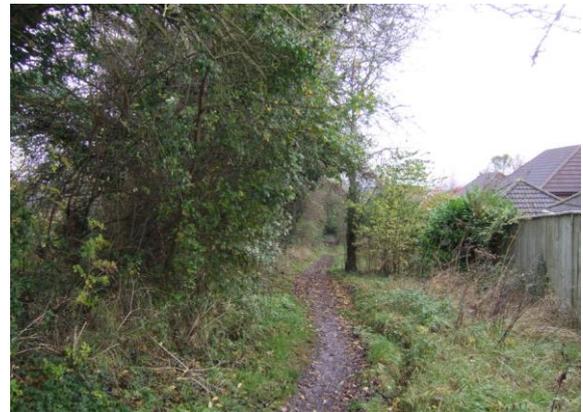
Photo 3.16: view facing south (upstream) at tree line where original ditch should be; Photo 3.17: view facing north (downstream) at ditch line; residents have attempted to dig ditch on right hand side of footpath to protect their property

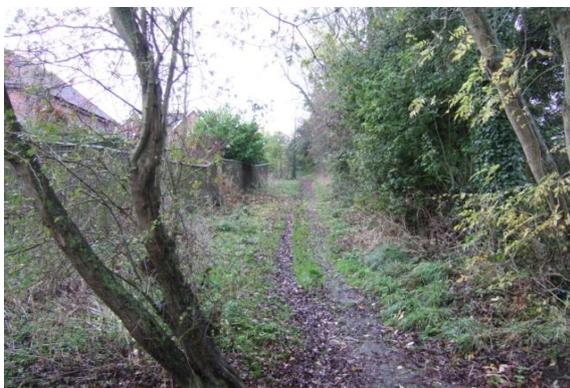
Photo 3.18: view facing north (upstream) at tree line where original ditch should be;

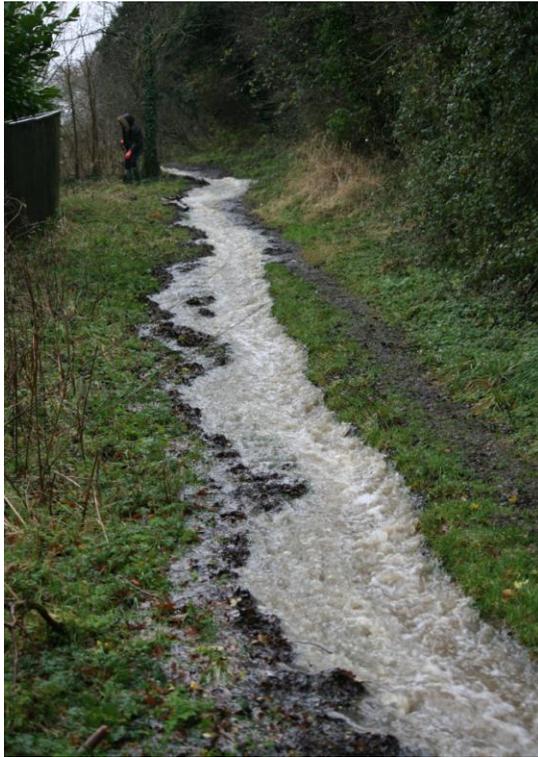
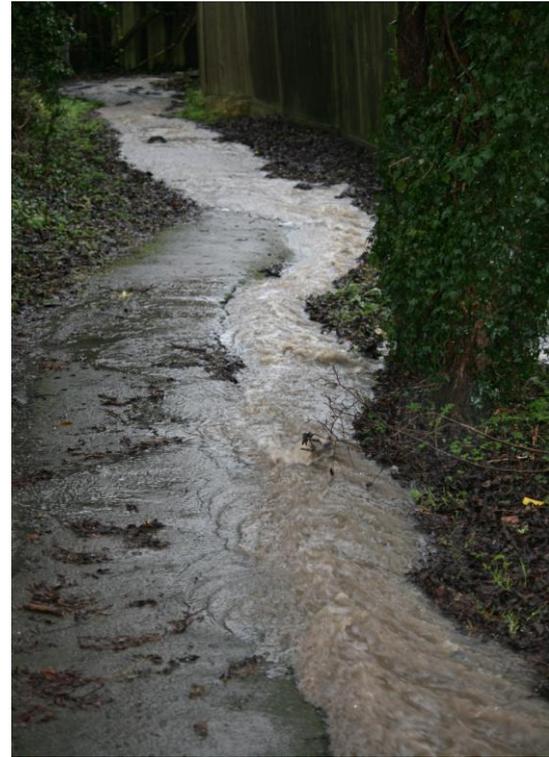
Photo 3.19 and 3.20: show flood water flowing down footpath from the field behind Springlines; the reason for this is the ditch has over the years been neglected and disappeared; possibly since the development of the residential area. Water now finds the footpath as the quickest route downhill.

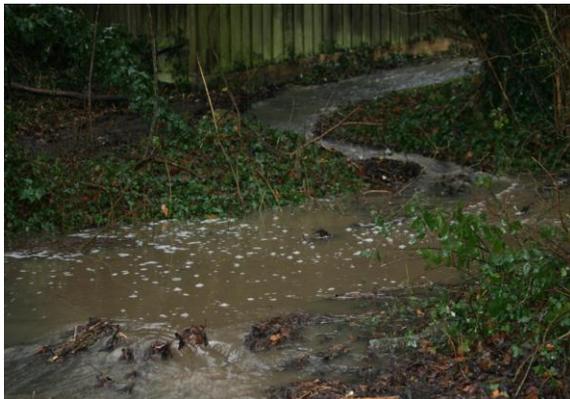
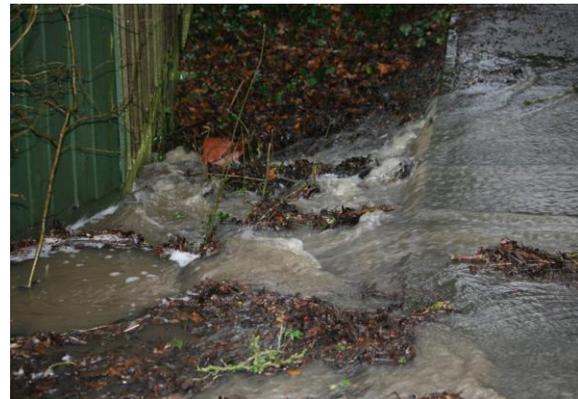
Photo 3.21 and 3.22: water continues to flow down footpath and over the top of culverted section of intercepting footpath into the gardens of Oak Apple Close, which have a well kept section of ditch which extends to the Beanlands headwall where it then connects and attempts to discharge into the Thames Water storm/surface water sewer. This is also a known problem area and is covered in the next downstream section.

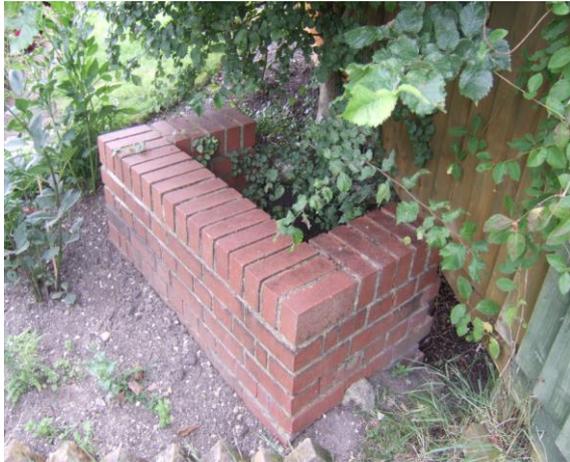
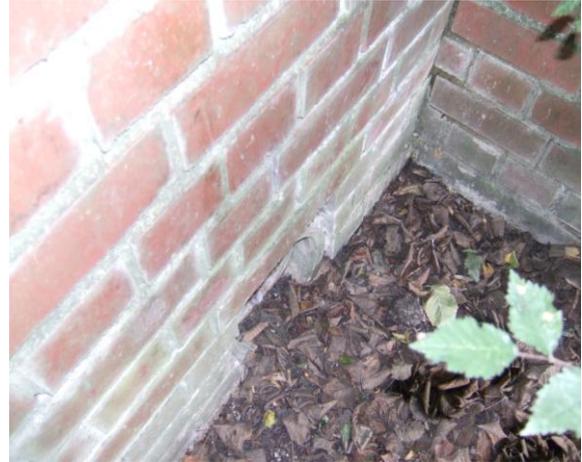
Photo 3.24 Headwall inlet to Thames Water sewers; Photo 3.25: shows 225mm culvert, possibly undersized. Another problem with this inlet is that it joins the main 450mm sewer at 90° right angle, so during heavy flows the 450mm sewer will act as a dam causing water to back-up and surcharge at the headwall inlet.

3. An improvement to the Thames Water surface water sewers is also an option, particularly at the right angled junctions namely Kimbers Field, Avenell Road, Magdalen Road and Yonder Way. However, it should be noted that the upstream attenuation recommendations would create a lot less pressure on the existing system.

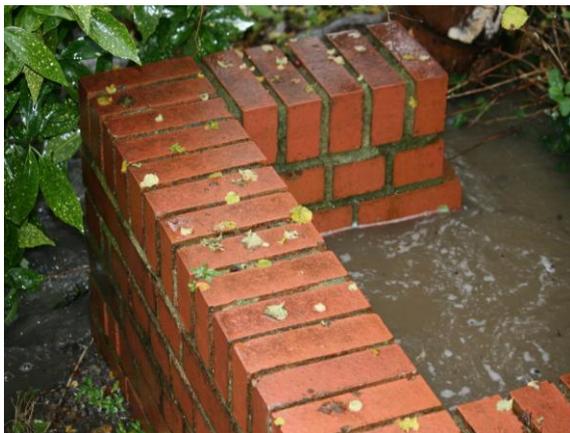
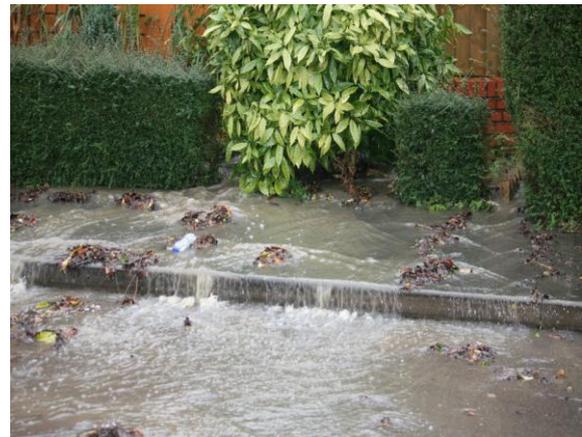
Photo 3.26 and Photo 3.27: show the headwall surcharging during the 2007 summer event.

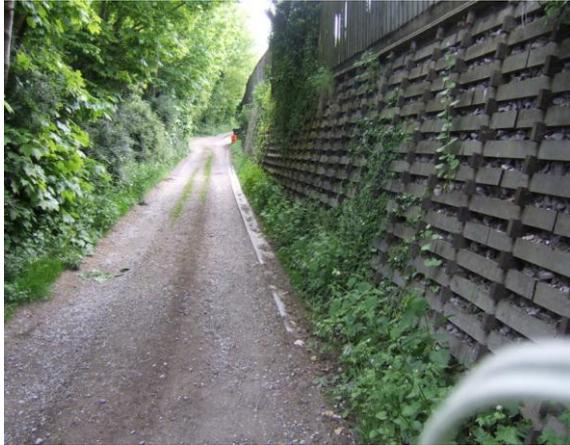
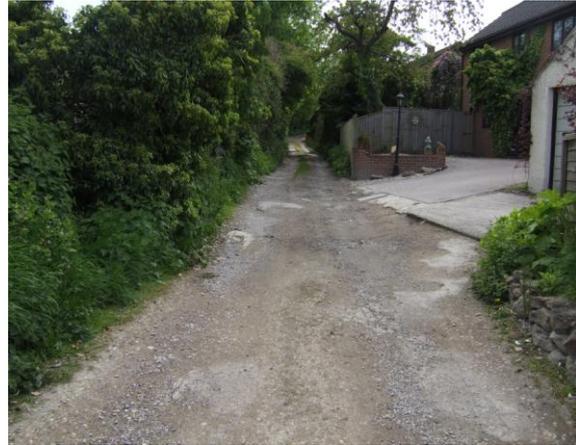
Photo 3.32: Looking upstream at the upper section of Chapel Lane; drainage requires further investigation as old ditch system lost. This section has only a shallow concrete channel to convey surface water. Photo 3.33: Looking upstream at the middle section of Chapel Lane; possibly original ditch system in hedge line and no evidence of drainage in this section, so water flows over track surface causing erosion and washing away materials.

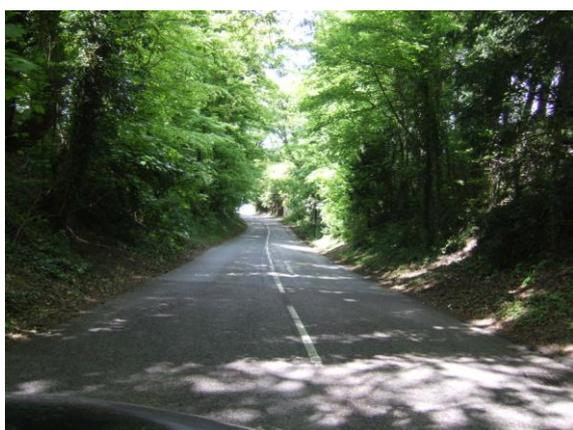
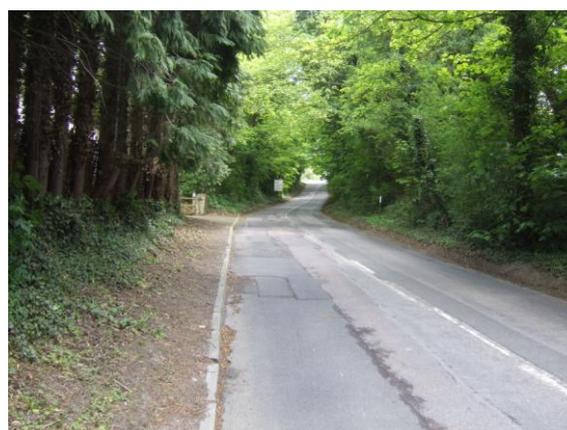
Photos 3.36 and 3.37: looking upstream towards top of High Street/Callas Hill. Heavy rainfall events would wash debris and vegetation from wooded area either side of road which then gets carried down the road and into gullies and culvert inlets causing blockages in the system.

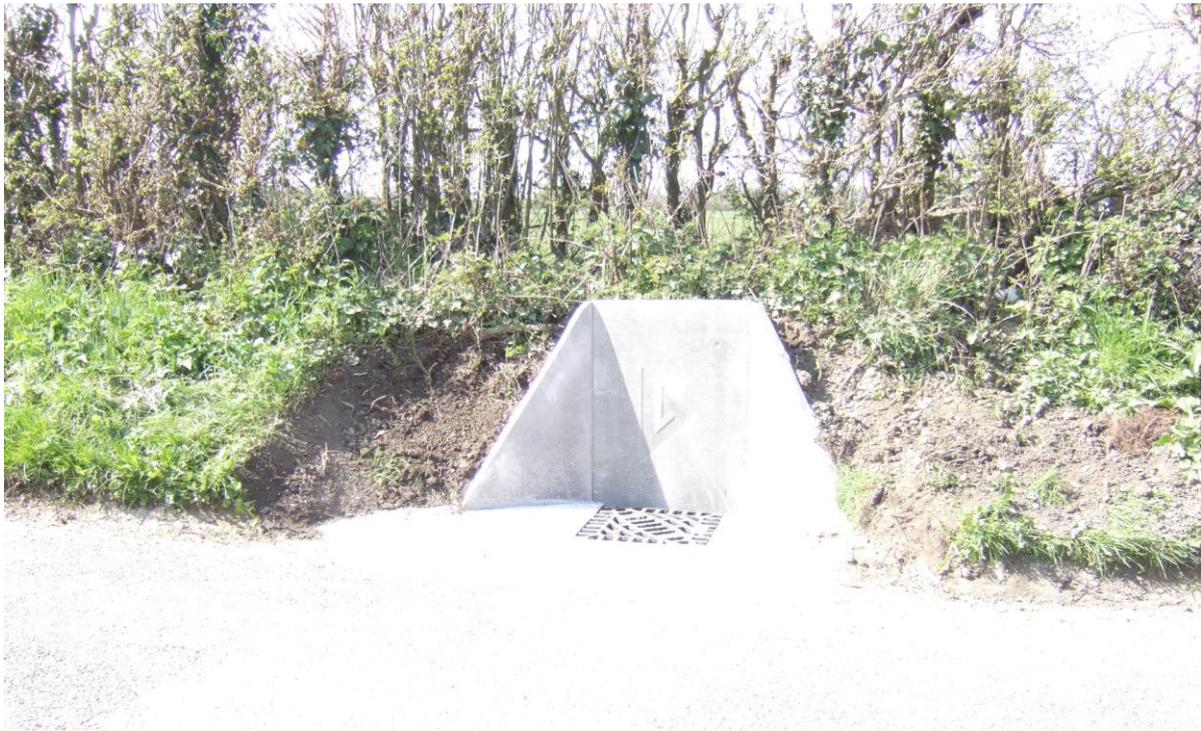
Photo 3.40: Shows an example of new roadside gully collection point with protective retaining wall structure. These have been introduced on a number of B-class roads throughout the county.

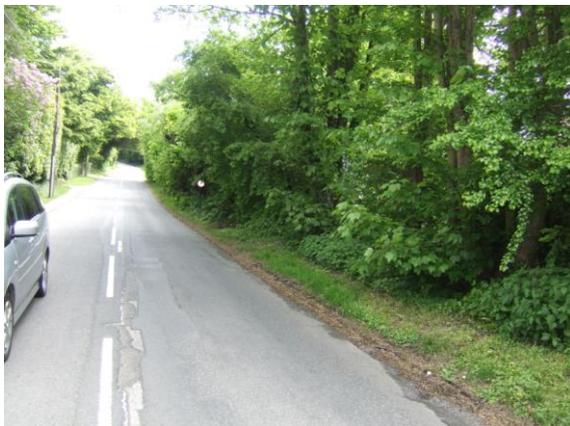
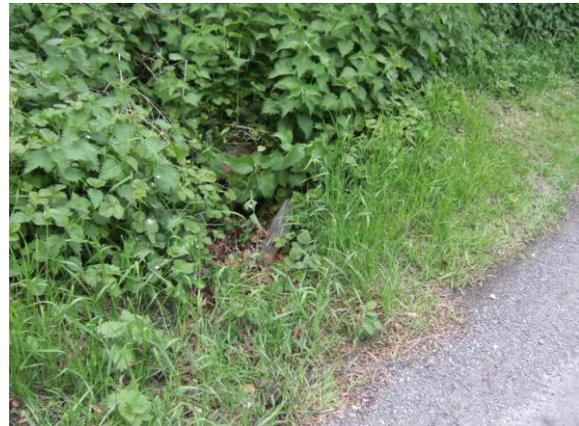
Photo 3.41: Photo 3.42: Further down the hill (High Street- west side) highway drainage combining piped and open ditch sections. Shows very little collection points/ grips etc also Photo 3.42 highlights susceptibility to blockage restriction to inlets.

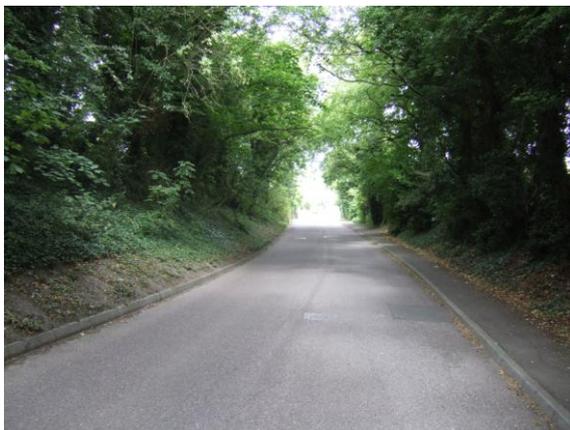
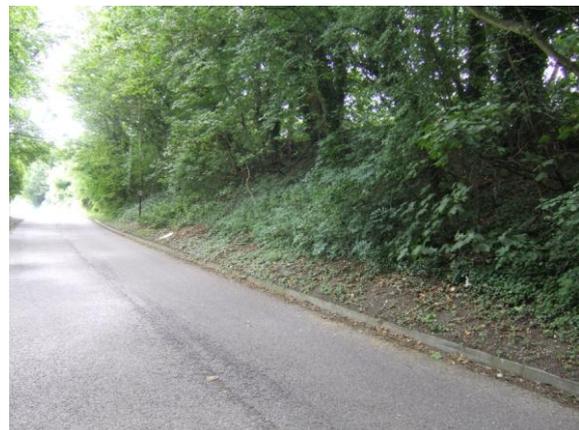
Photo 3.45 and Photo 3.46: views facing north and south near the top of Kite Hill; steep vegetated earth banks allow vegetation and soil debris to be washed onto road during rainfall

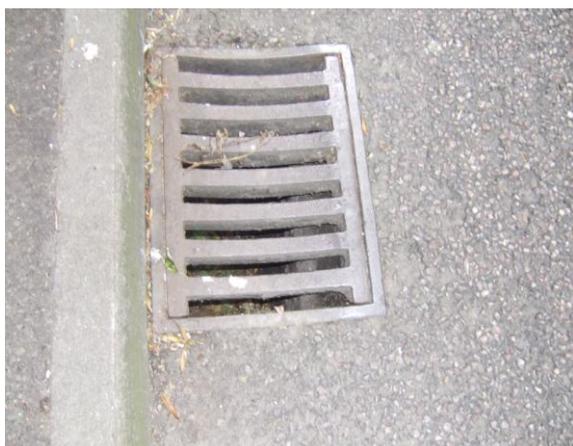
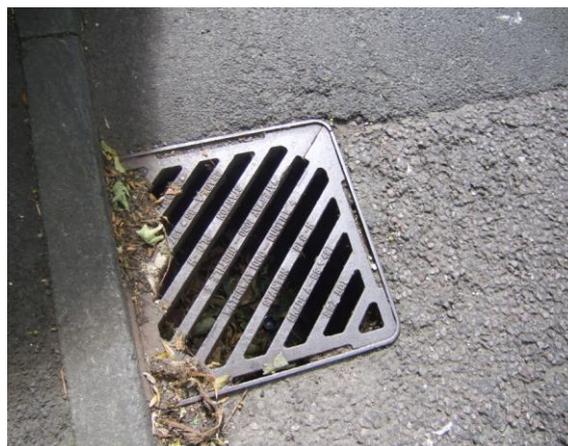
Photo 3.47 and 3.48: show the gullies in Kite Hill being filled with leaves etc causing the drains to surcharge and generate overland flows down the road.

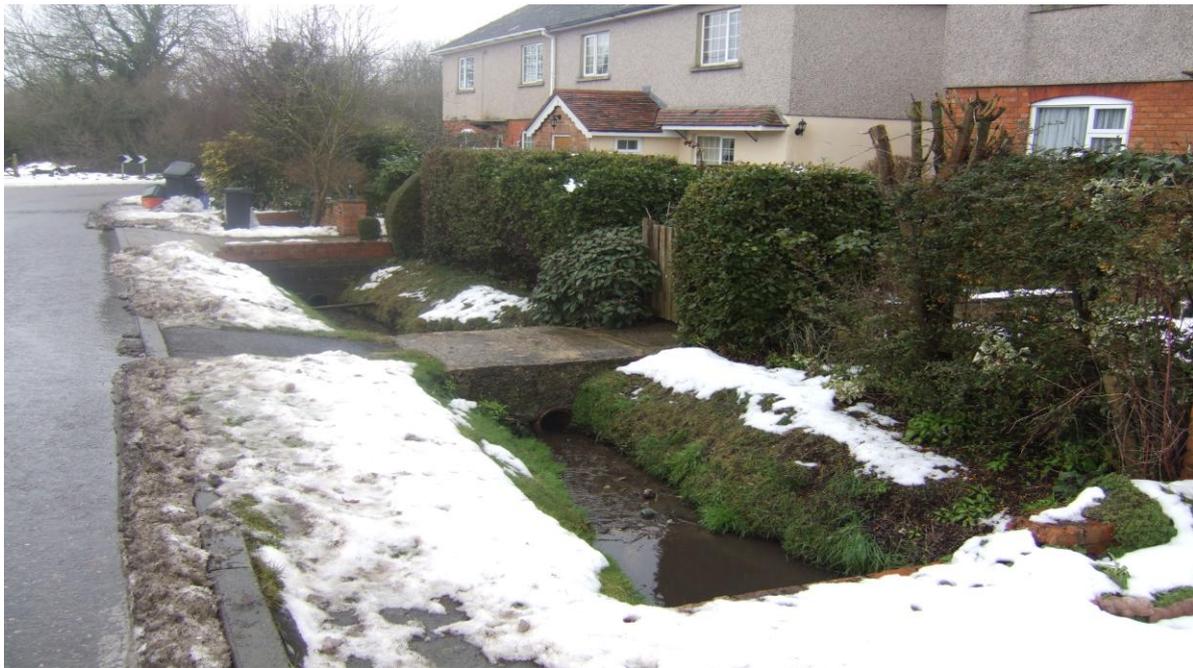
Photo 3.52: All the properties pictured above are listed as high risk of flooding; this picture highlights 2 possible reasons for flooding. 1] The properties are lower than the road. 2] The stream crossings will restrict heavy flows as the culverts are far too small and the concrete pathways above them effectively form dam like structures which would be feasible in rural areas to hold back flows; similar to 'stank'-type weirs.

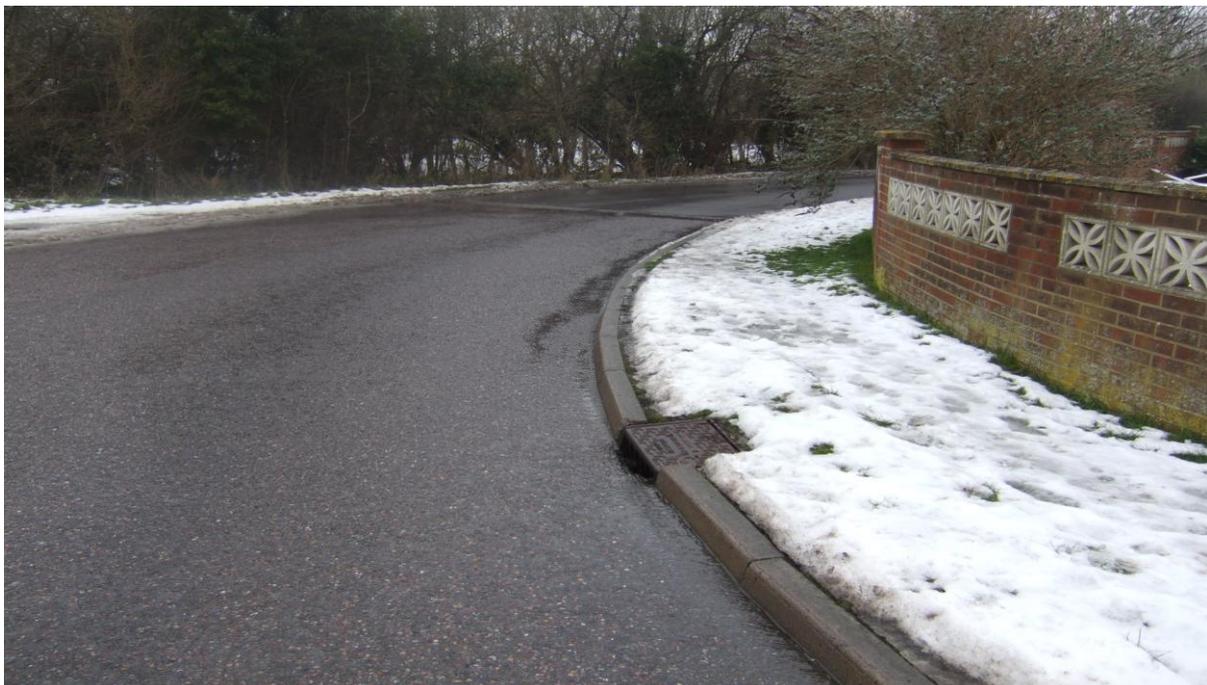
Photo 3.53: View at the foot of Kite Hill where it joins with Rotten Row Kerbside gully connects with

culverted section beneath footpath before discharging into ditch against tree line

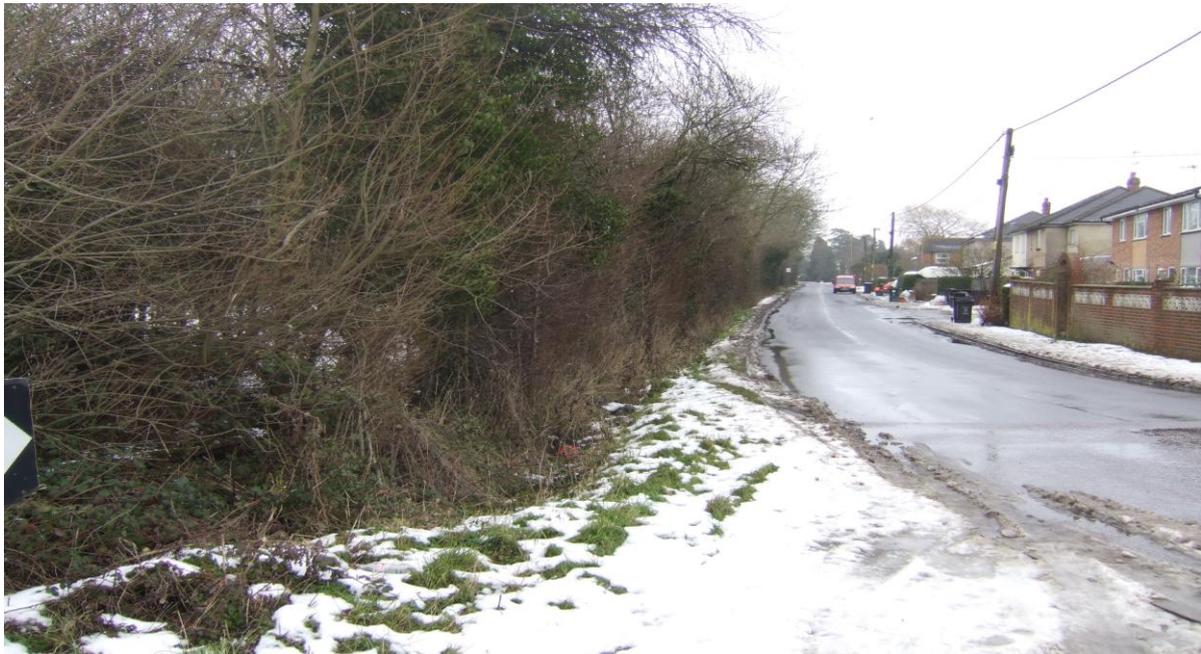
Photo 3.54: View looking east down Rotten Row; Highway ditch needs clearing

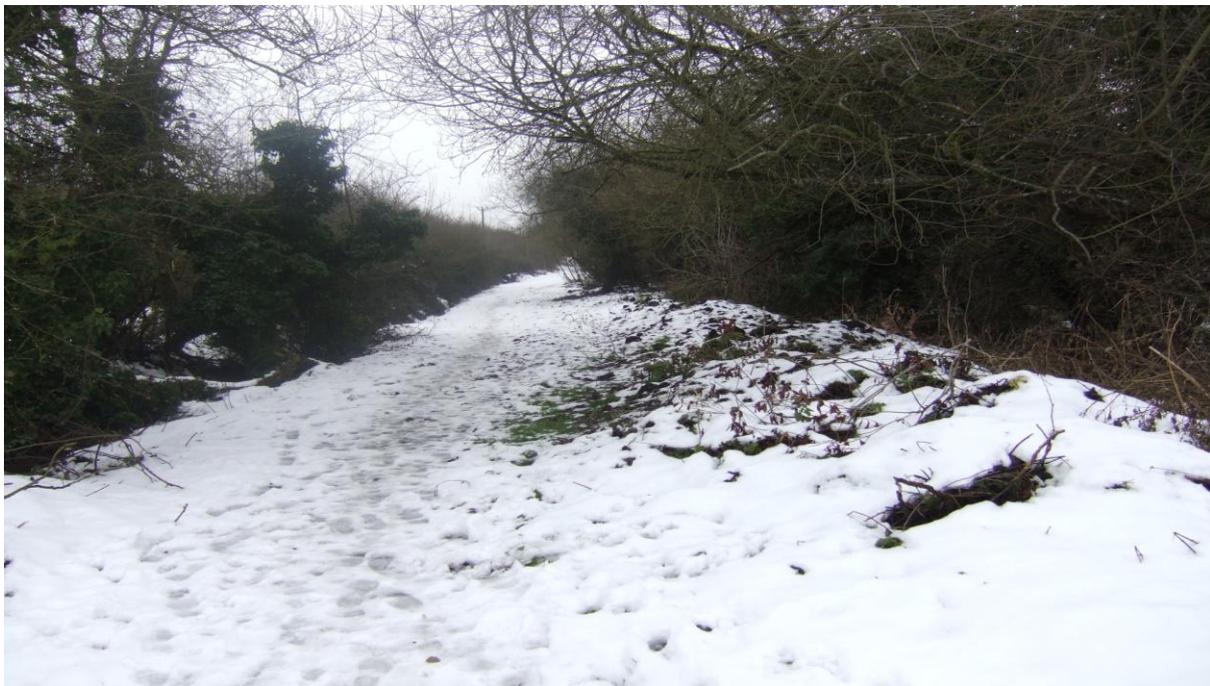
Photo 3.55: View looking north down Green Lane; ditch on both sides can be reinstated. Ideal place for flow attenuation /retaining structures instead of existing location at west ditch in Kite Hill

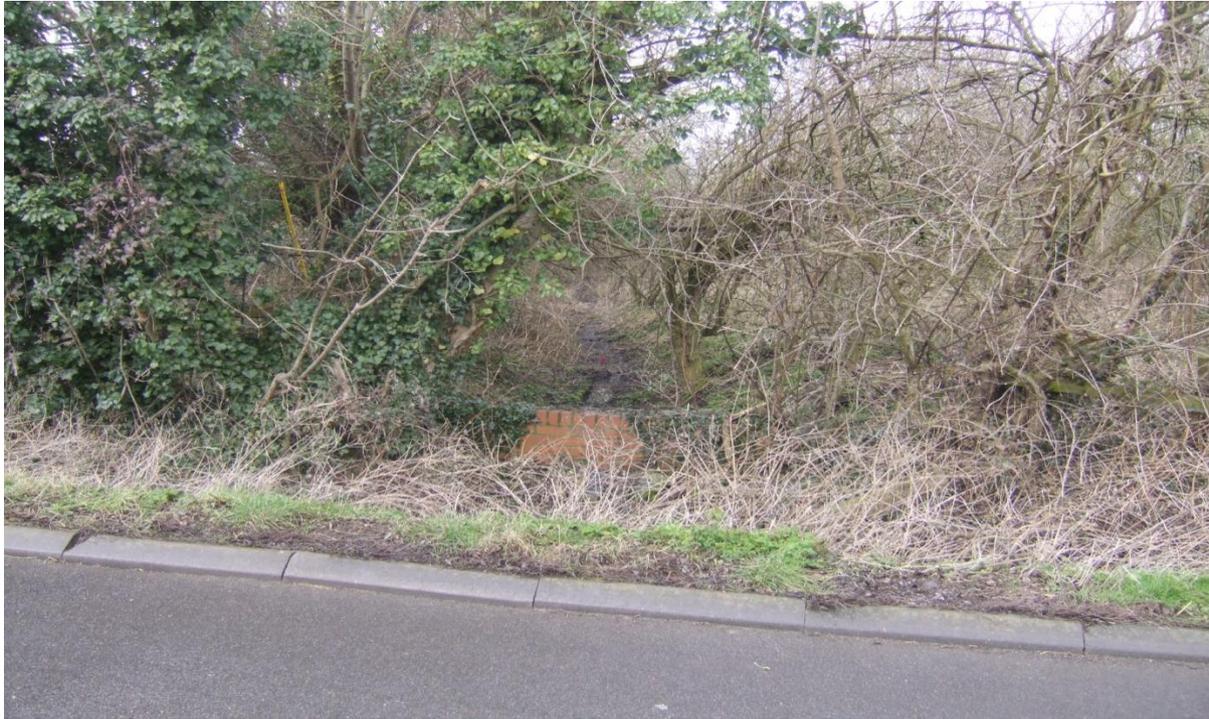
Photo 3.63: Another view showing headwall and intercepting ditch (west to east) which forms part of highway drain system, but also collects water from Kite Hill (east side).

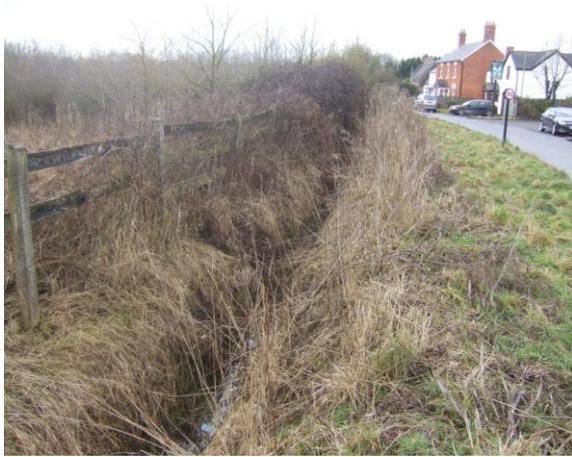
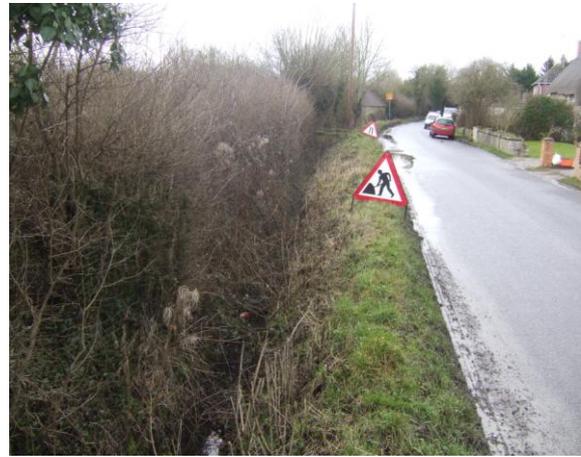
Photo 3.64: View facing west along Burycroft ditch; ditch can be widened here to allow for more storage. Photo 3.65: Another view facing west; surface water on road can be removed by introducing grips

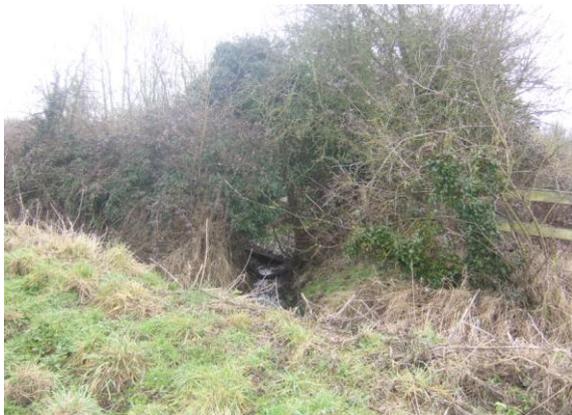
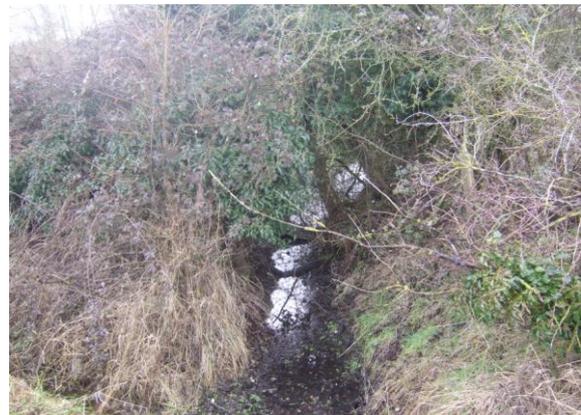
Photo 3.66 and Photo 3.67: Ditch from Rotten Row joining with Burycroft

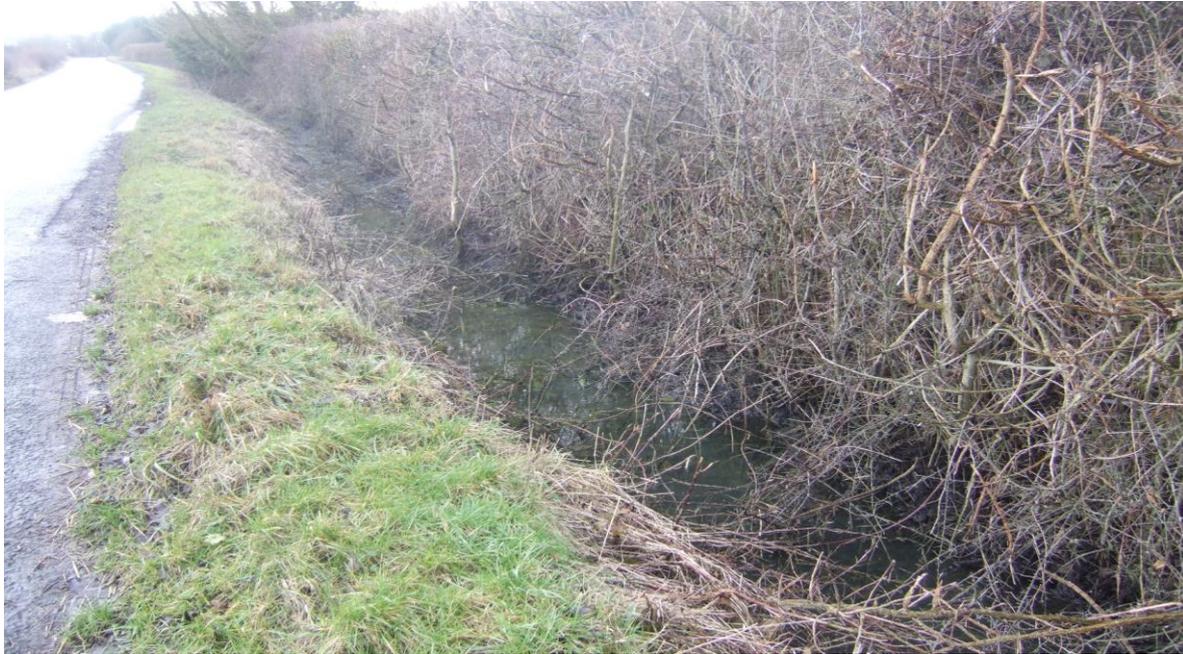
Poorly maintained ditches: the ditch along the marsh road between Moorlease and Cedar Vale requires some attention (Photos 3.68-3.71).

Photo 3.68: View facing south towards Moorleaze; stagnant water in ditch close to watershed: water here should flow north through the culvert access in photo 3.23 and continue along poorly maintained section of ditch photo 3.24 Then discharging into piped section to Cedar Vale

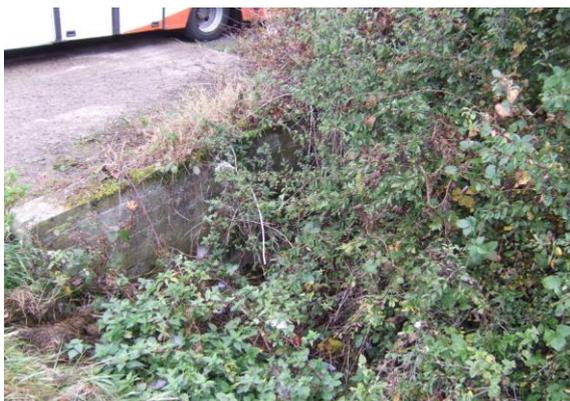
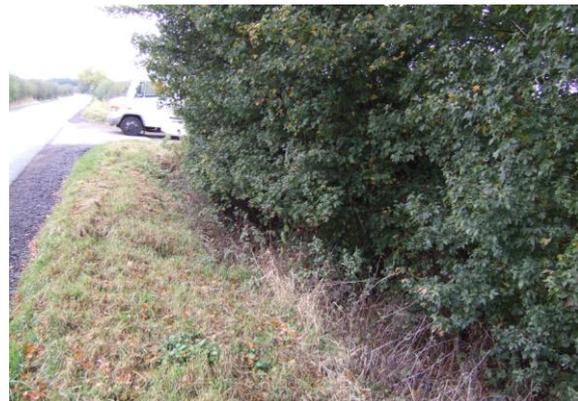
Photo-3.69: Well built field access culvert at point of watershed on Marsh Road; Photo-3.70: ditch downstream of culvert continues to Applegate House.

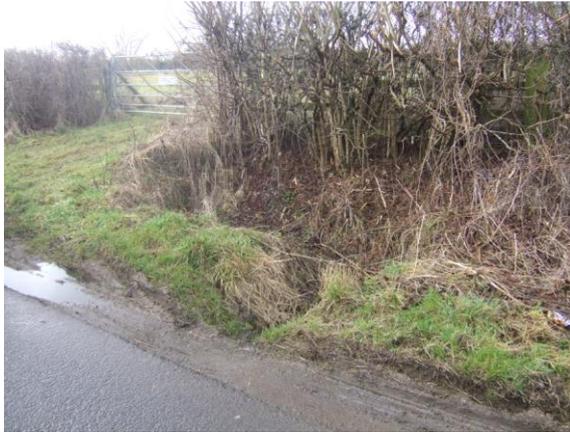
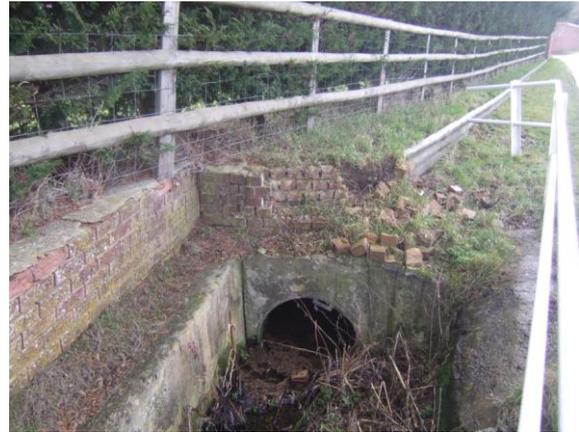
Photo-3.71: ditch continues to this section adjacent to Applegate House; from here it discharges into 600mm diameter piped ditch section; Photo-3.72 shows the outlet from land drain through Applegate House and Inlands Farm; this is conveyed through culvert beneath Marsh Road then also discharged into 600mm piped section.

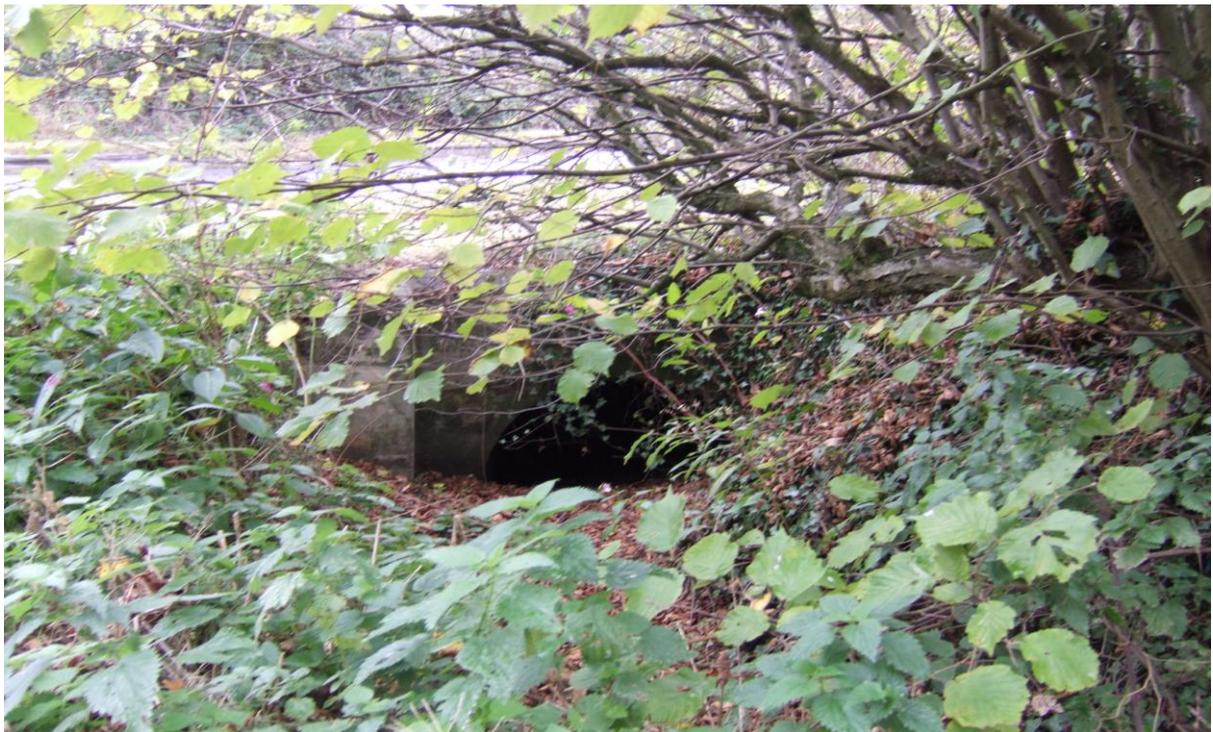
Photo-3.73: Outlet into Cedar Vale land drain

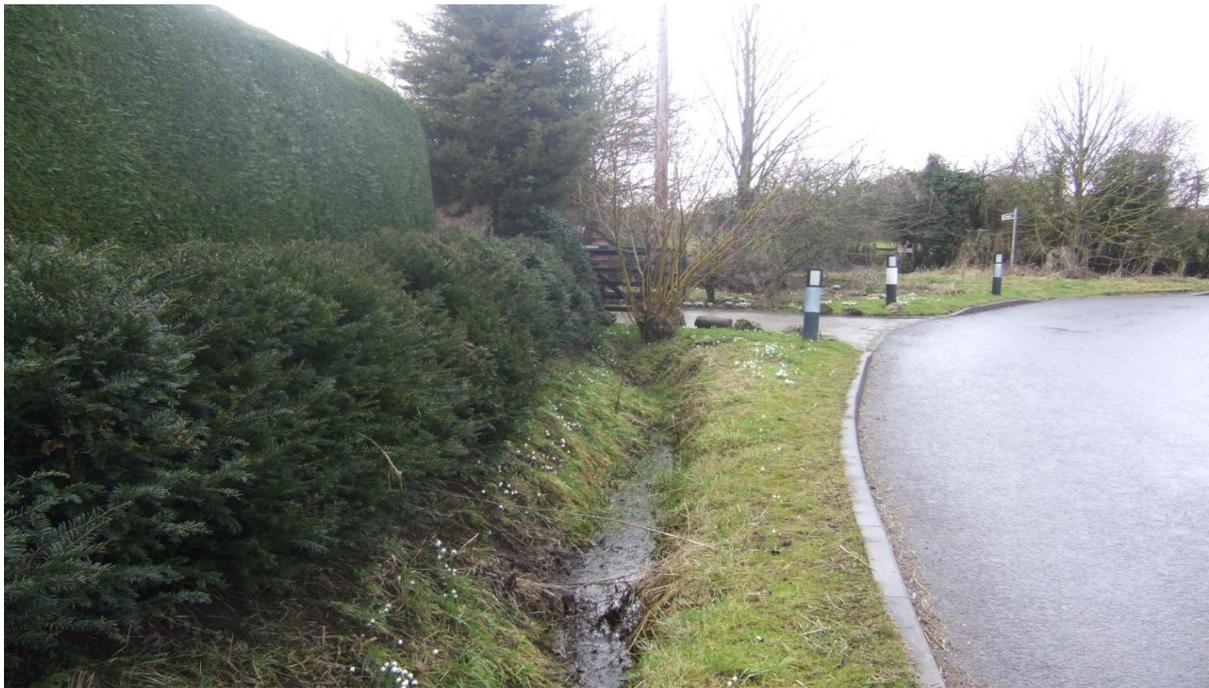
The ditch adjacent to Marshlea is in reasonable condition; however the water seems to have nowhere to go, as there is no culvert beneath the driveway linking it to the ditch downstream, which does require some attention.

Photo-3.74: Roadside ditch outside Marshlea residential property; not a highway drain but drains land on which the residential properties are located. Access drive should have culvert beneath it to allow this water to drain towards Cedar Vale.

The culvert beneath Marshlea access drive (Photo 3.28) should ideally be reinstated allowing water to drain away. The option of doing nothing here is not critical however, but may cause some light highway flooding. The culvert beneath the field access should be reinstated unless gateway no longer used then ditch to be reopened.

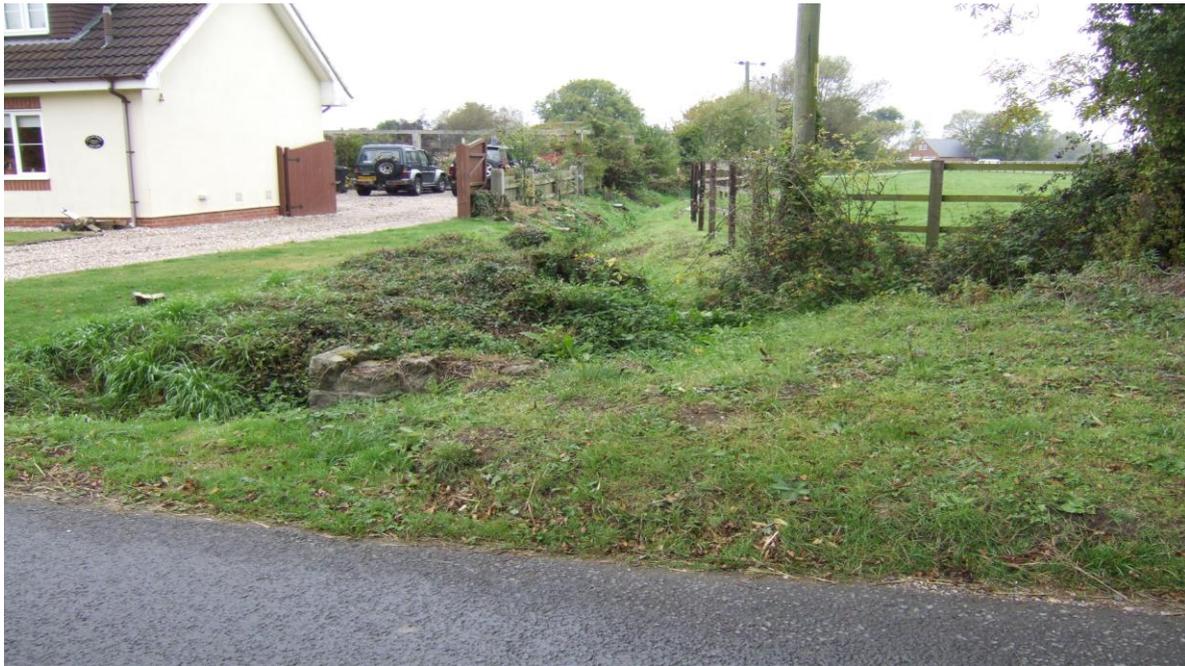
Photo-3.76: View facing north at land drain adjacent The Marsh. This land drain requires improvements; SBC have commenced some works (Appendix H) continuing negotiations with land owners

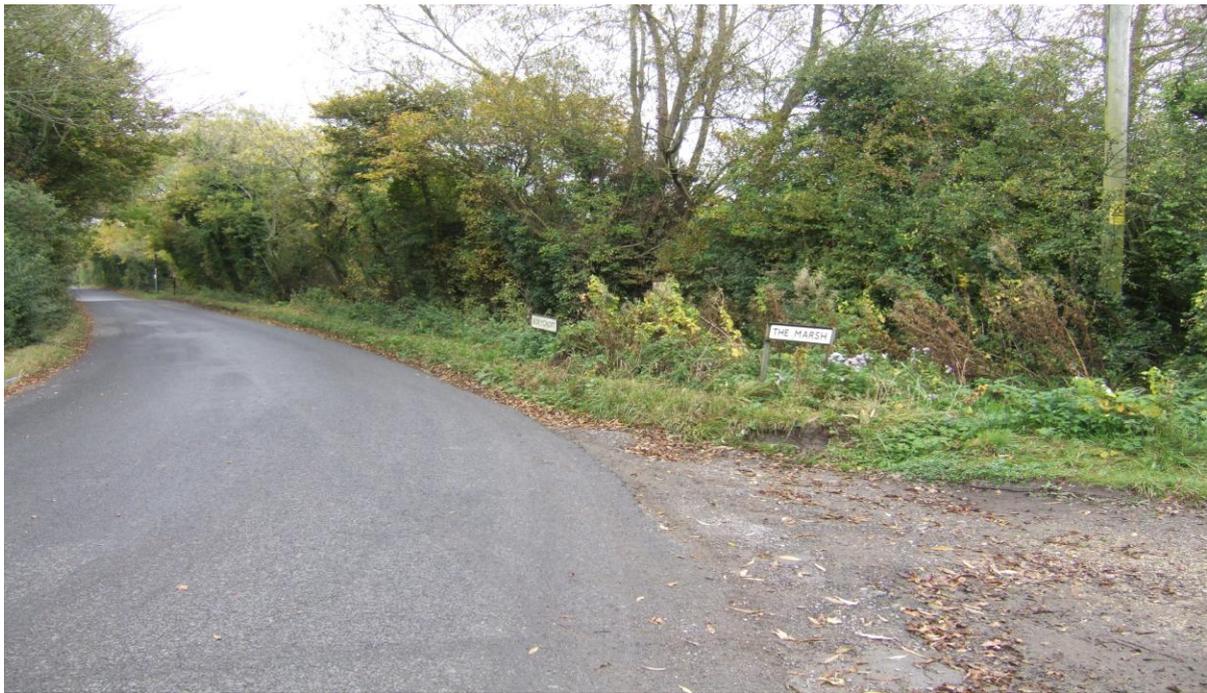
Photo-3.78: View where The Marsh meets Burycroft via Green Lane

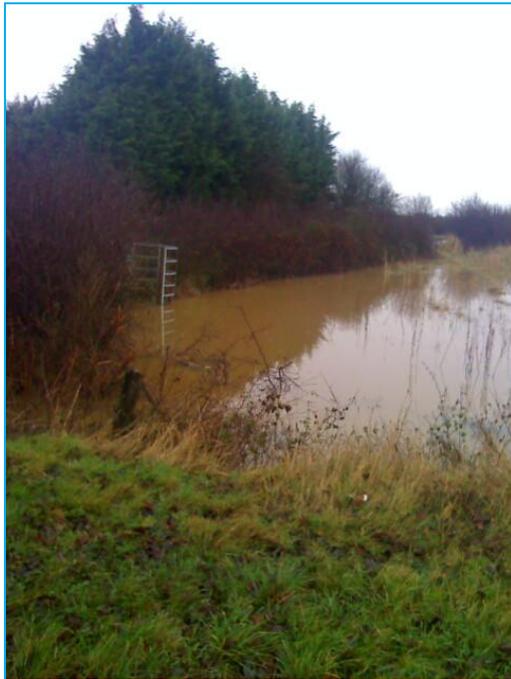
Photo 3.85. Flooding in field adjacent to Great Moorleaze Farm. Good attenuation area. However, original ditches around field may have been backfilled some years ago. It is also assumed that a culvert existed in the corner of field to disperse water into drainage system across road and into Liden Brook.

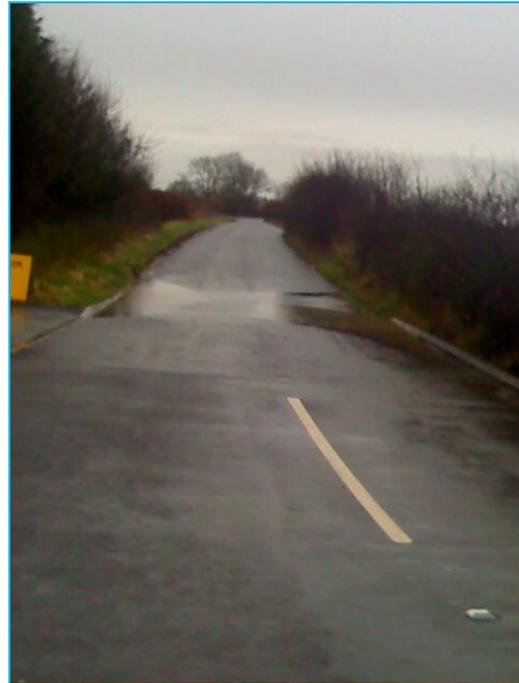
Photo 3.86: Is this line of original culvert beneath road? SBC to investigate with vector and cctv. Drainage on opposite side of road around Great Moorleaze Farm boundary will need to be investigated and reinstated.

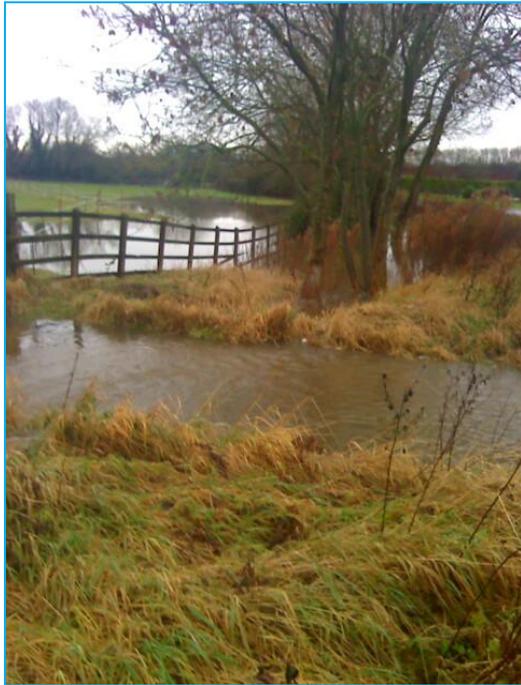
Photo 3.87: Flooding at foot of Pack Hill, July 2007; SBC have cleared ditch and installed new larger culvert.

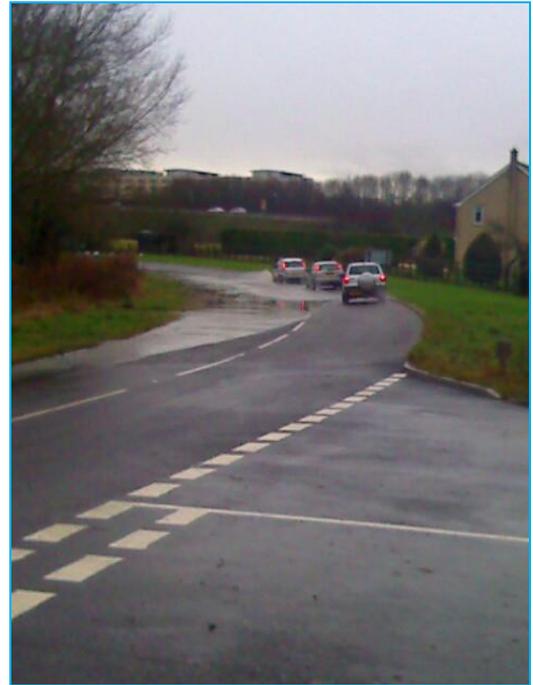
Photo 3.88: Flooding on Pack Hill road; SBC have since dug out grips. However, this area may require further improvements, i.e. more grips.
