WANBOROUGH FLOOD AND DRAINAGE MANAGEMENT REPORT

Wanborough, Swindon, Wiltshire

Revised Report: February 2011

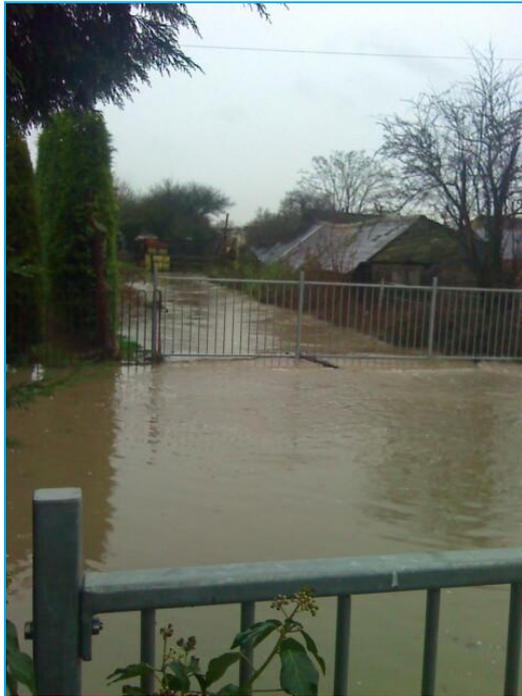
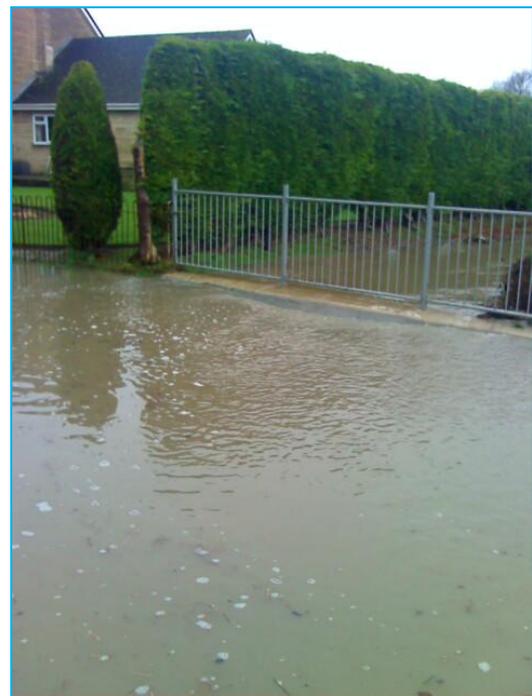
Photo 3.89 and Photo 3.90; Flooding of the Liden Brook, July 2007.

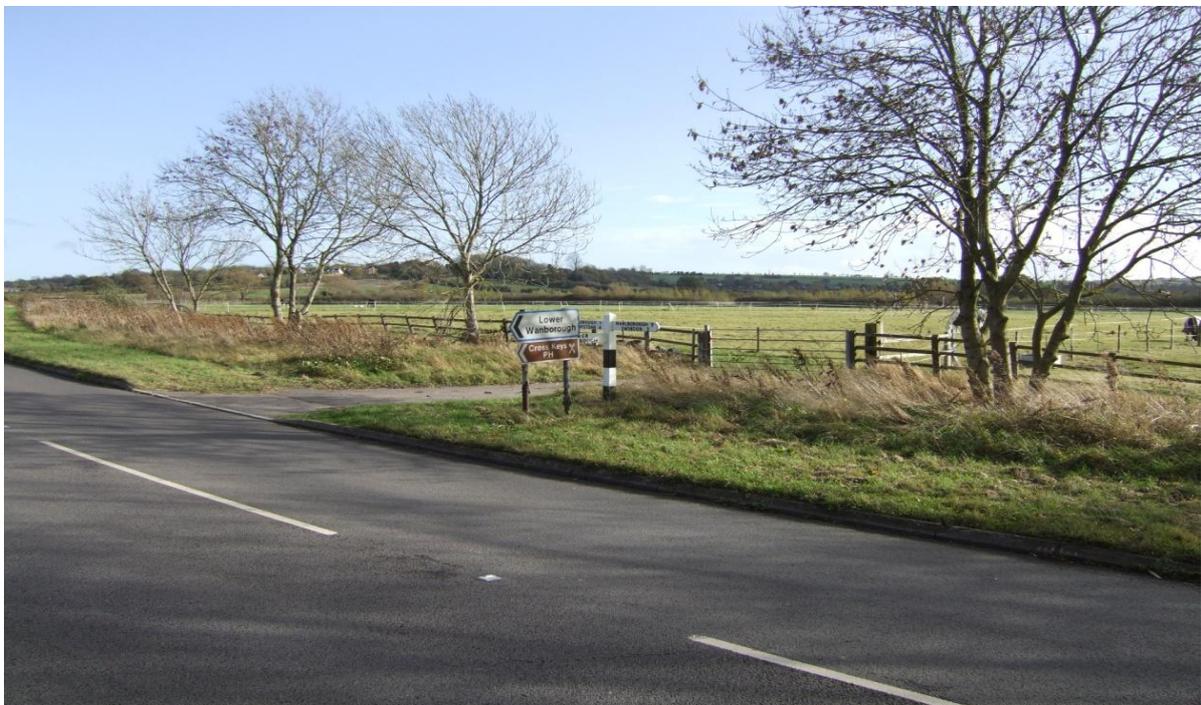
Photo 3.91. Pack Hill/Moorleaze Ditch (South)

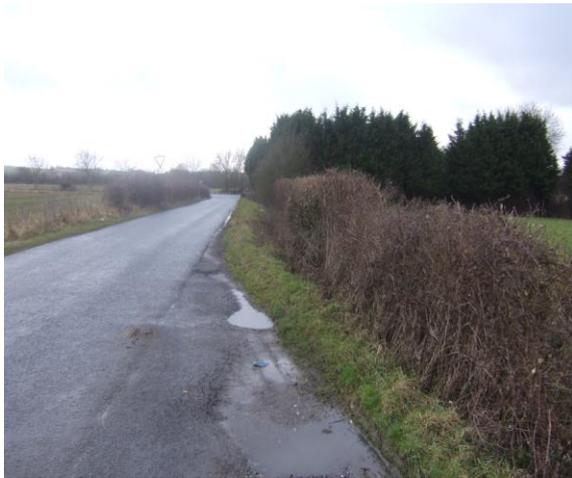
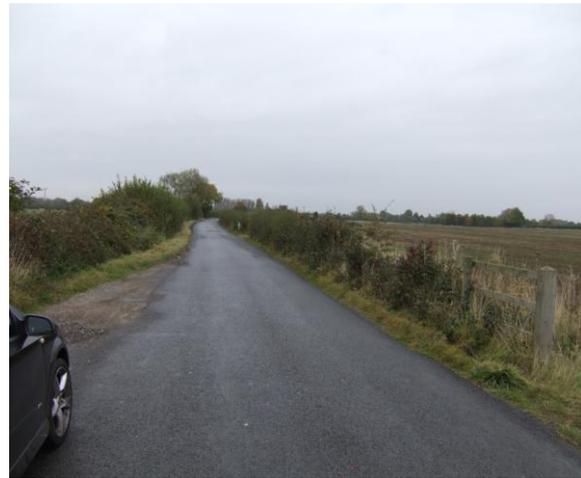
Photo 3.94 / 3.95 no evidence of culvert beneath this lay-by probably buried over time due to poor maintenance. However, this does disconnect flows from upstream which would be beneficial to the Moorleaze area and possible a good location to divert flows west straight to the Liden Brook

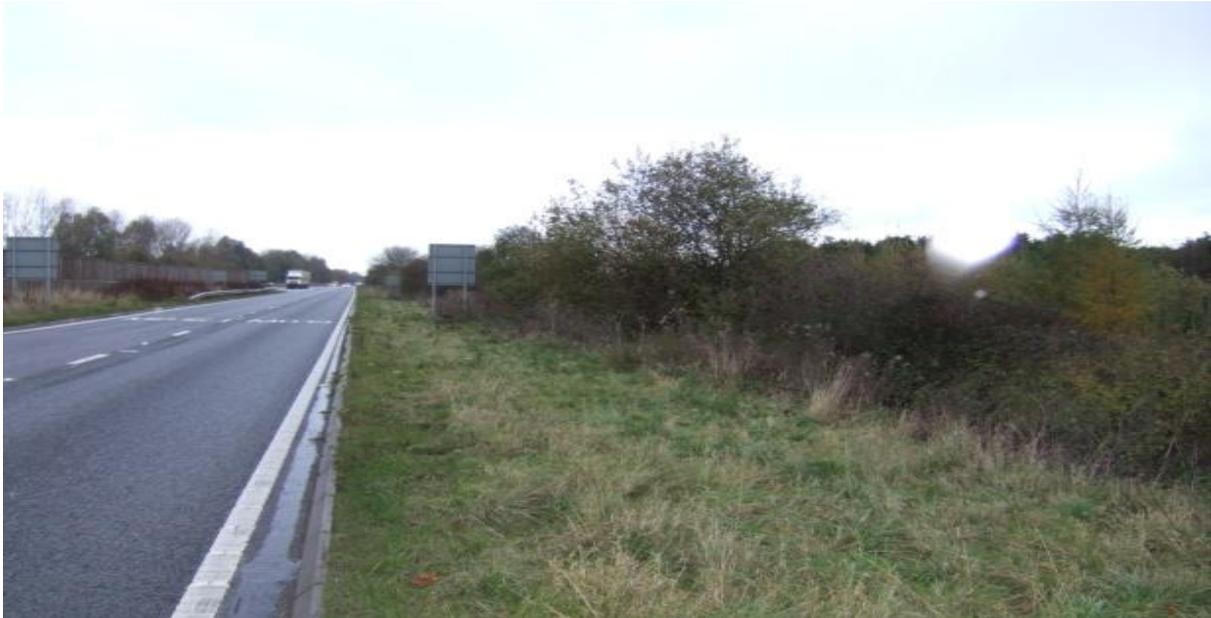
Photo 3.96: View northwards junction sliproad with drainage ditch on the right

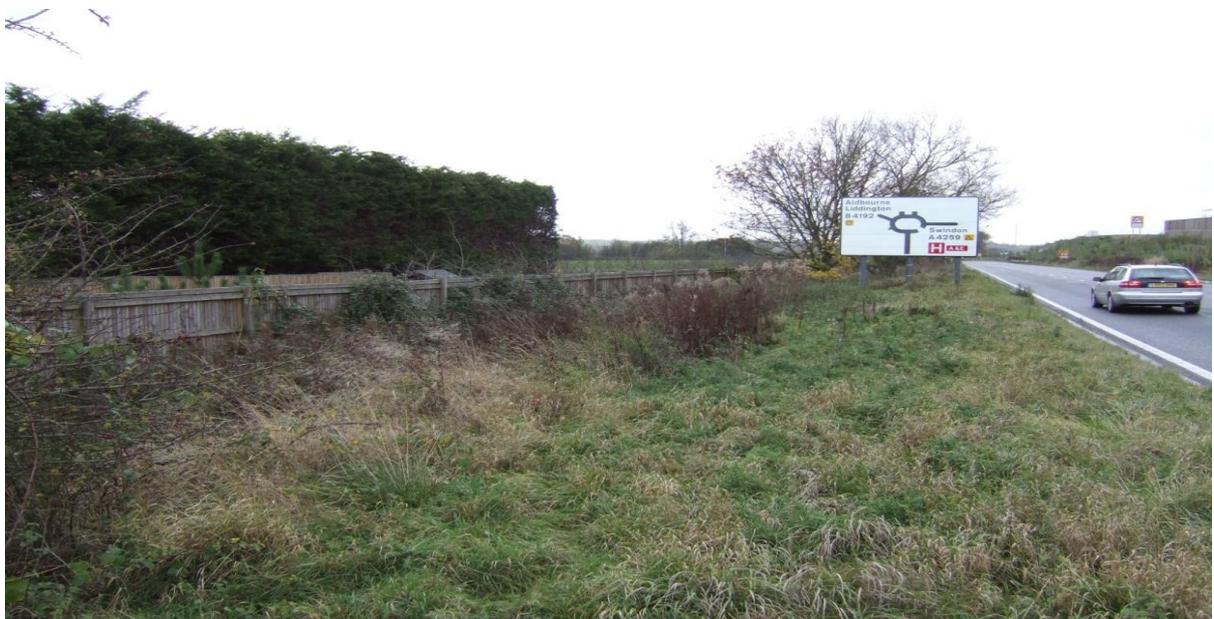
Photo 3.97 View southwards junction sliproad with drainage ditch on the left

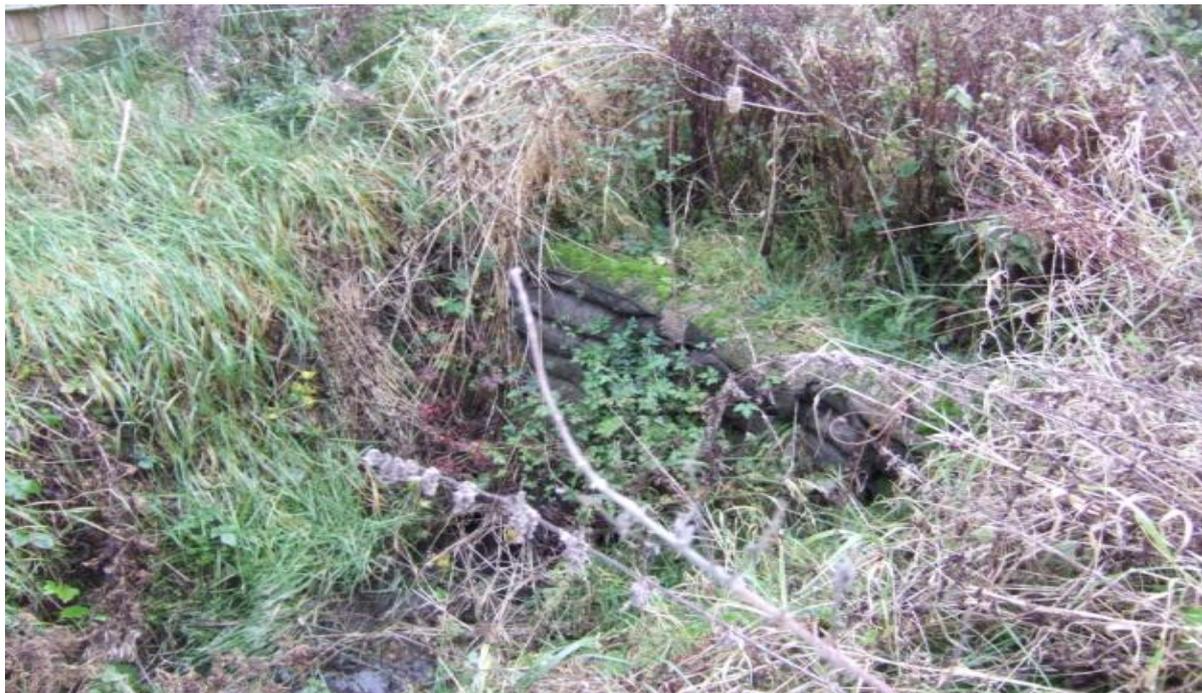
Photo 3.98 Flow control structure – headwall and culvert within ditch

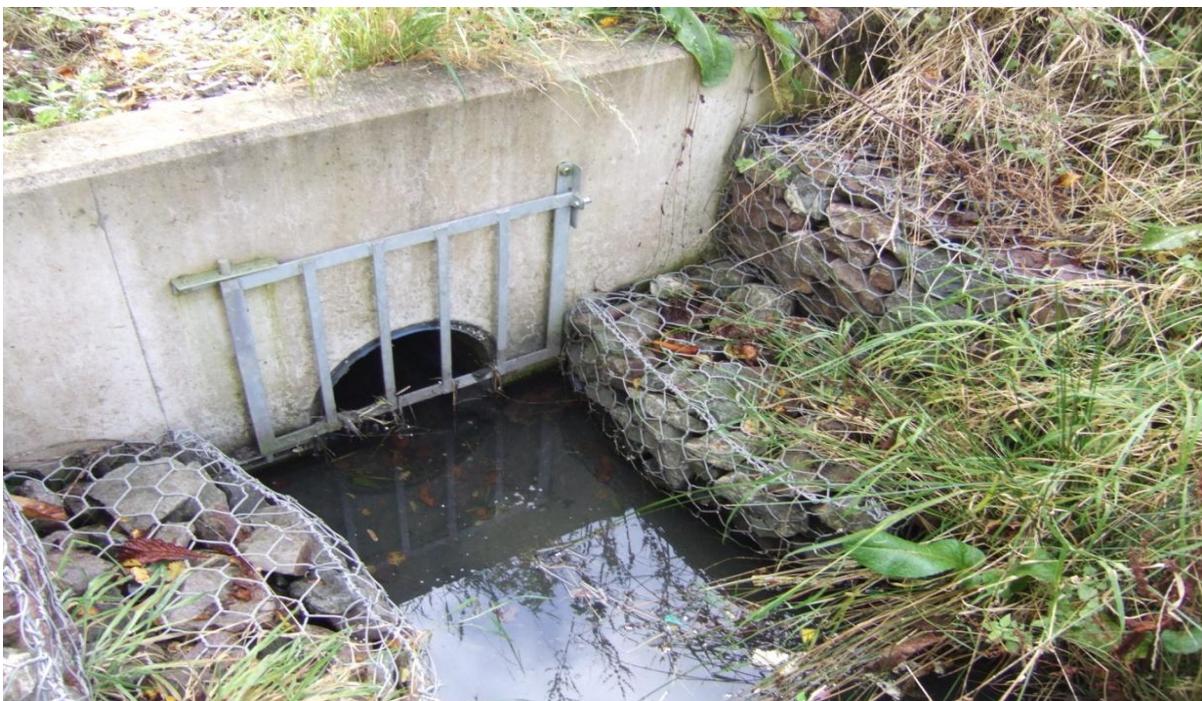
Photo 3.99 Outlet structure – headwall and culvert within ditch

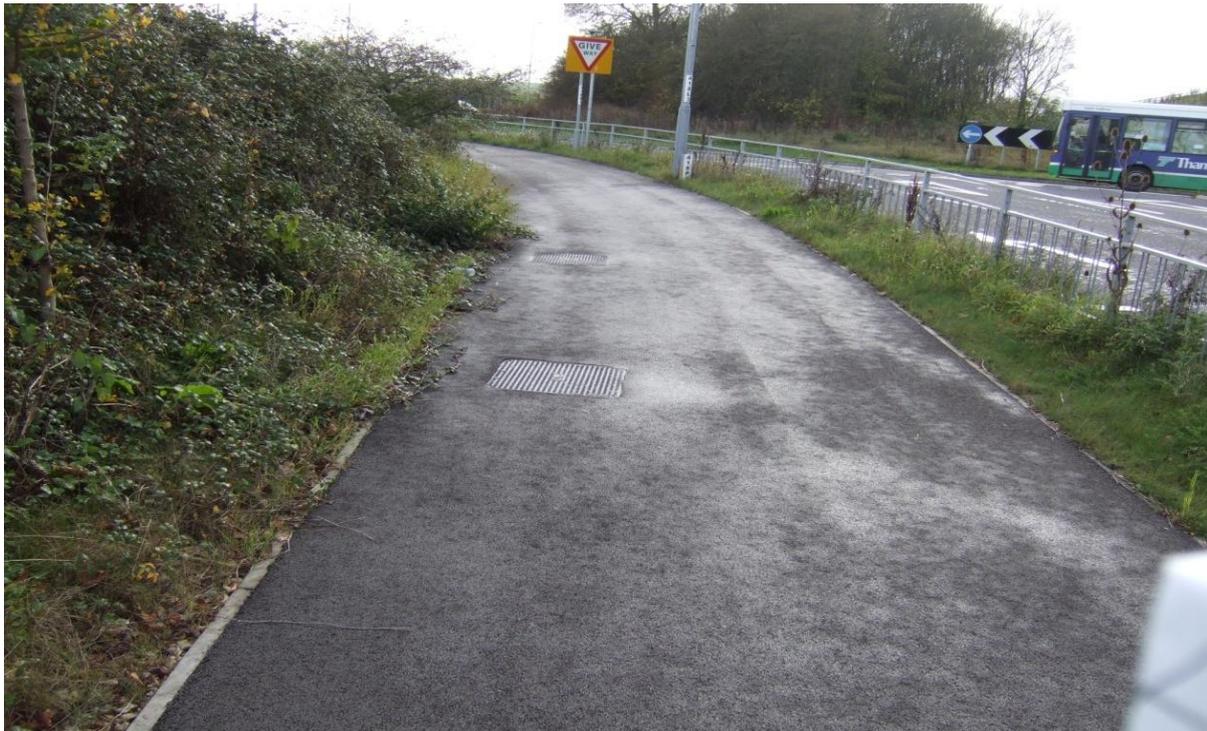
Photo 3.100 south facing – ditch piped beneath footway to open ditch

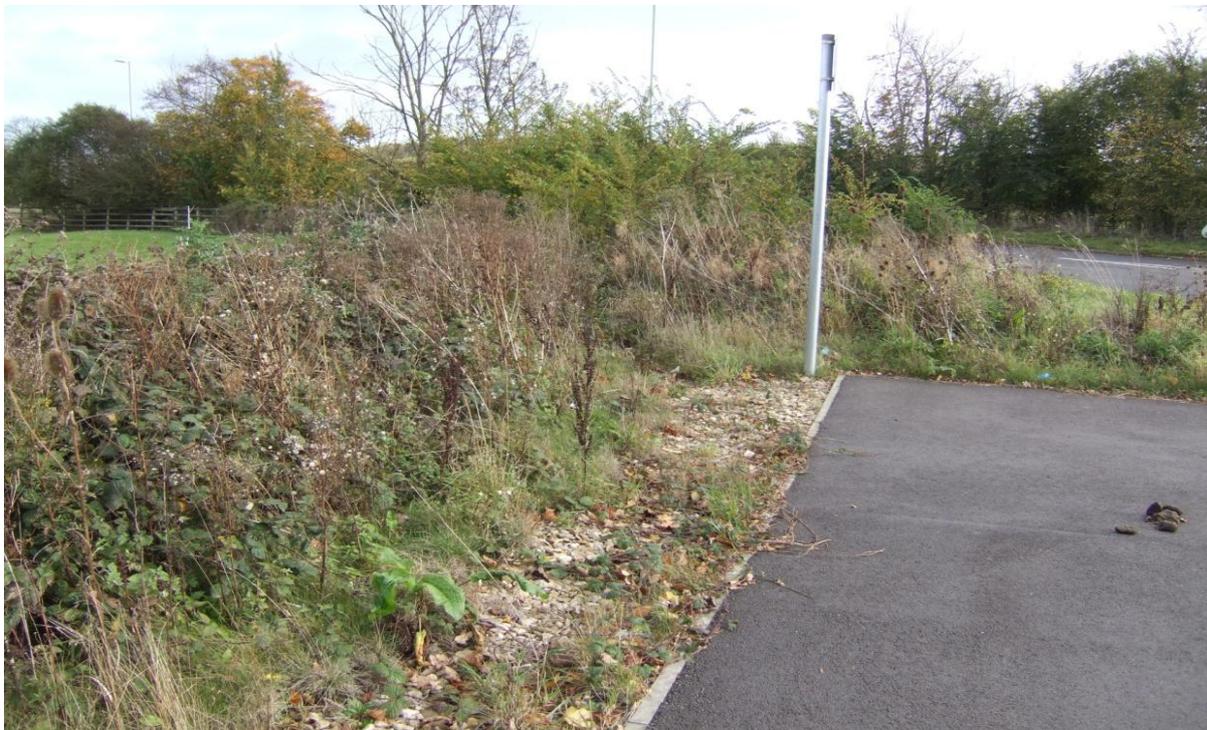
Photo 3.101 south facing – ditch piped beneath footway to open ditch

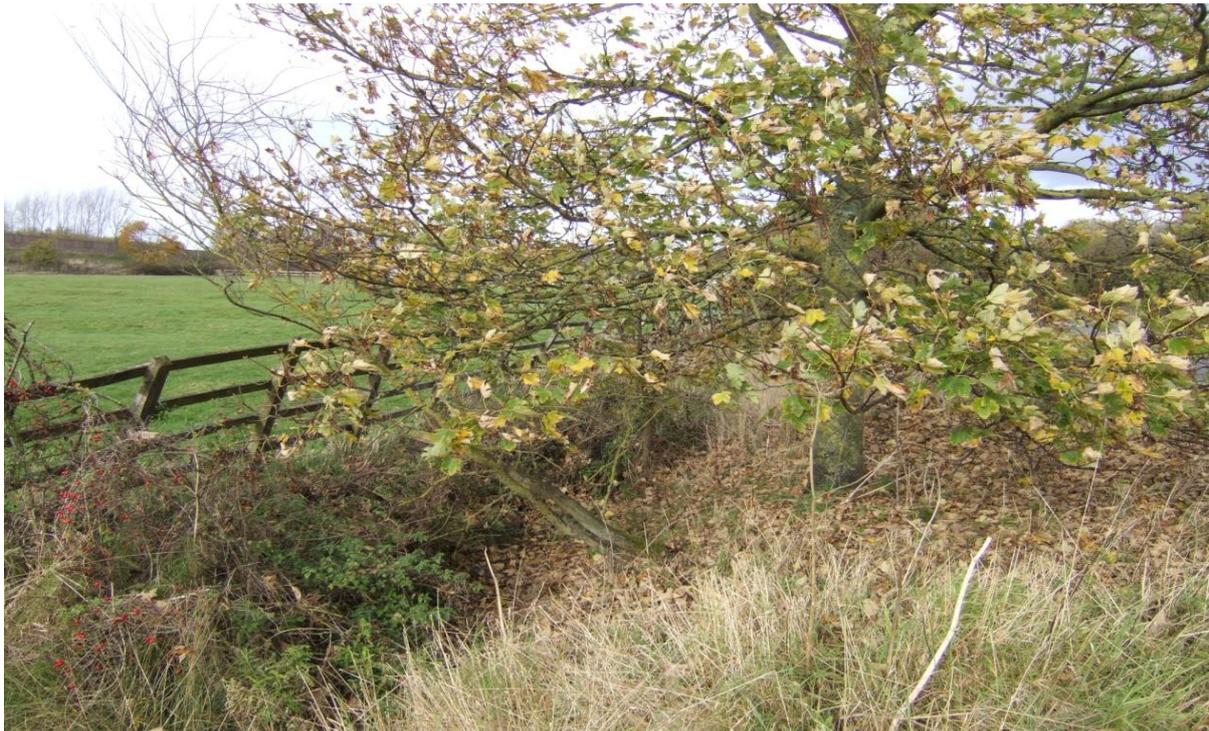
Photo 3.102 Open ditch south of Moorleaze Farm

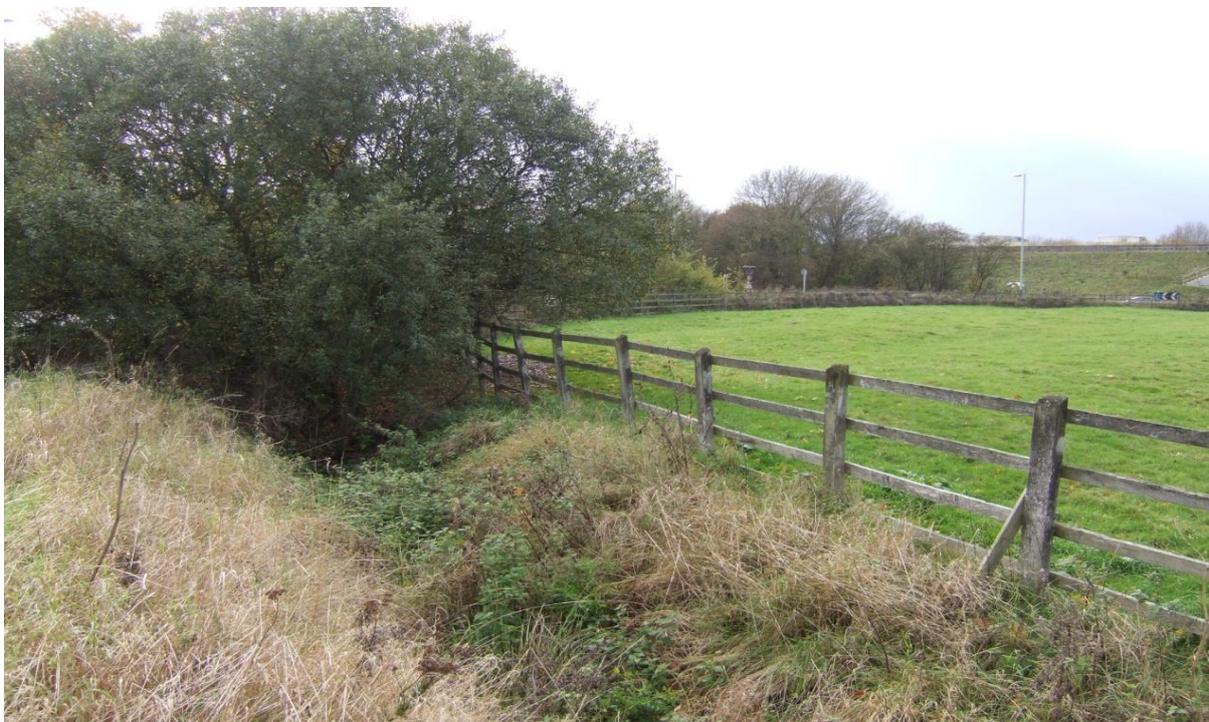
Photo 3.103 Open ditch south of Moorleaze Farm
