| Wanborough Flood Assessment | |
| Title : A3 view 4 | |

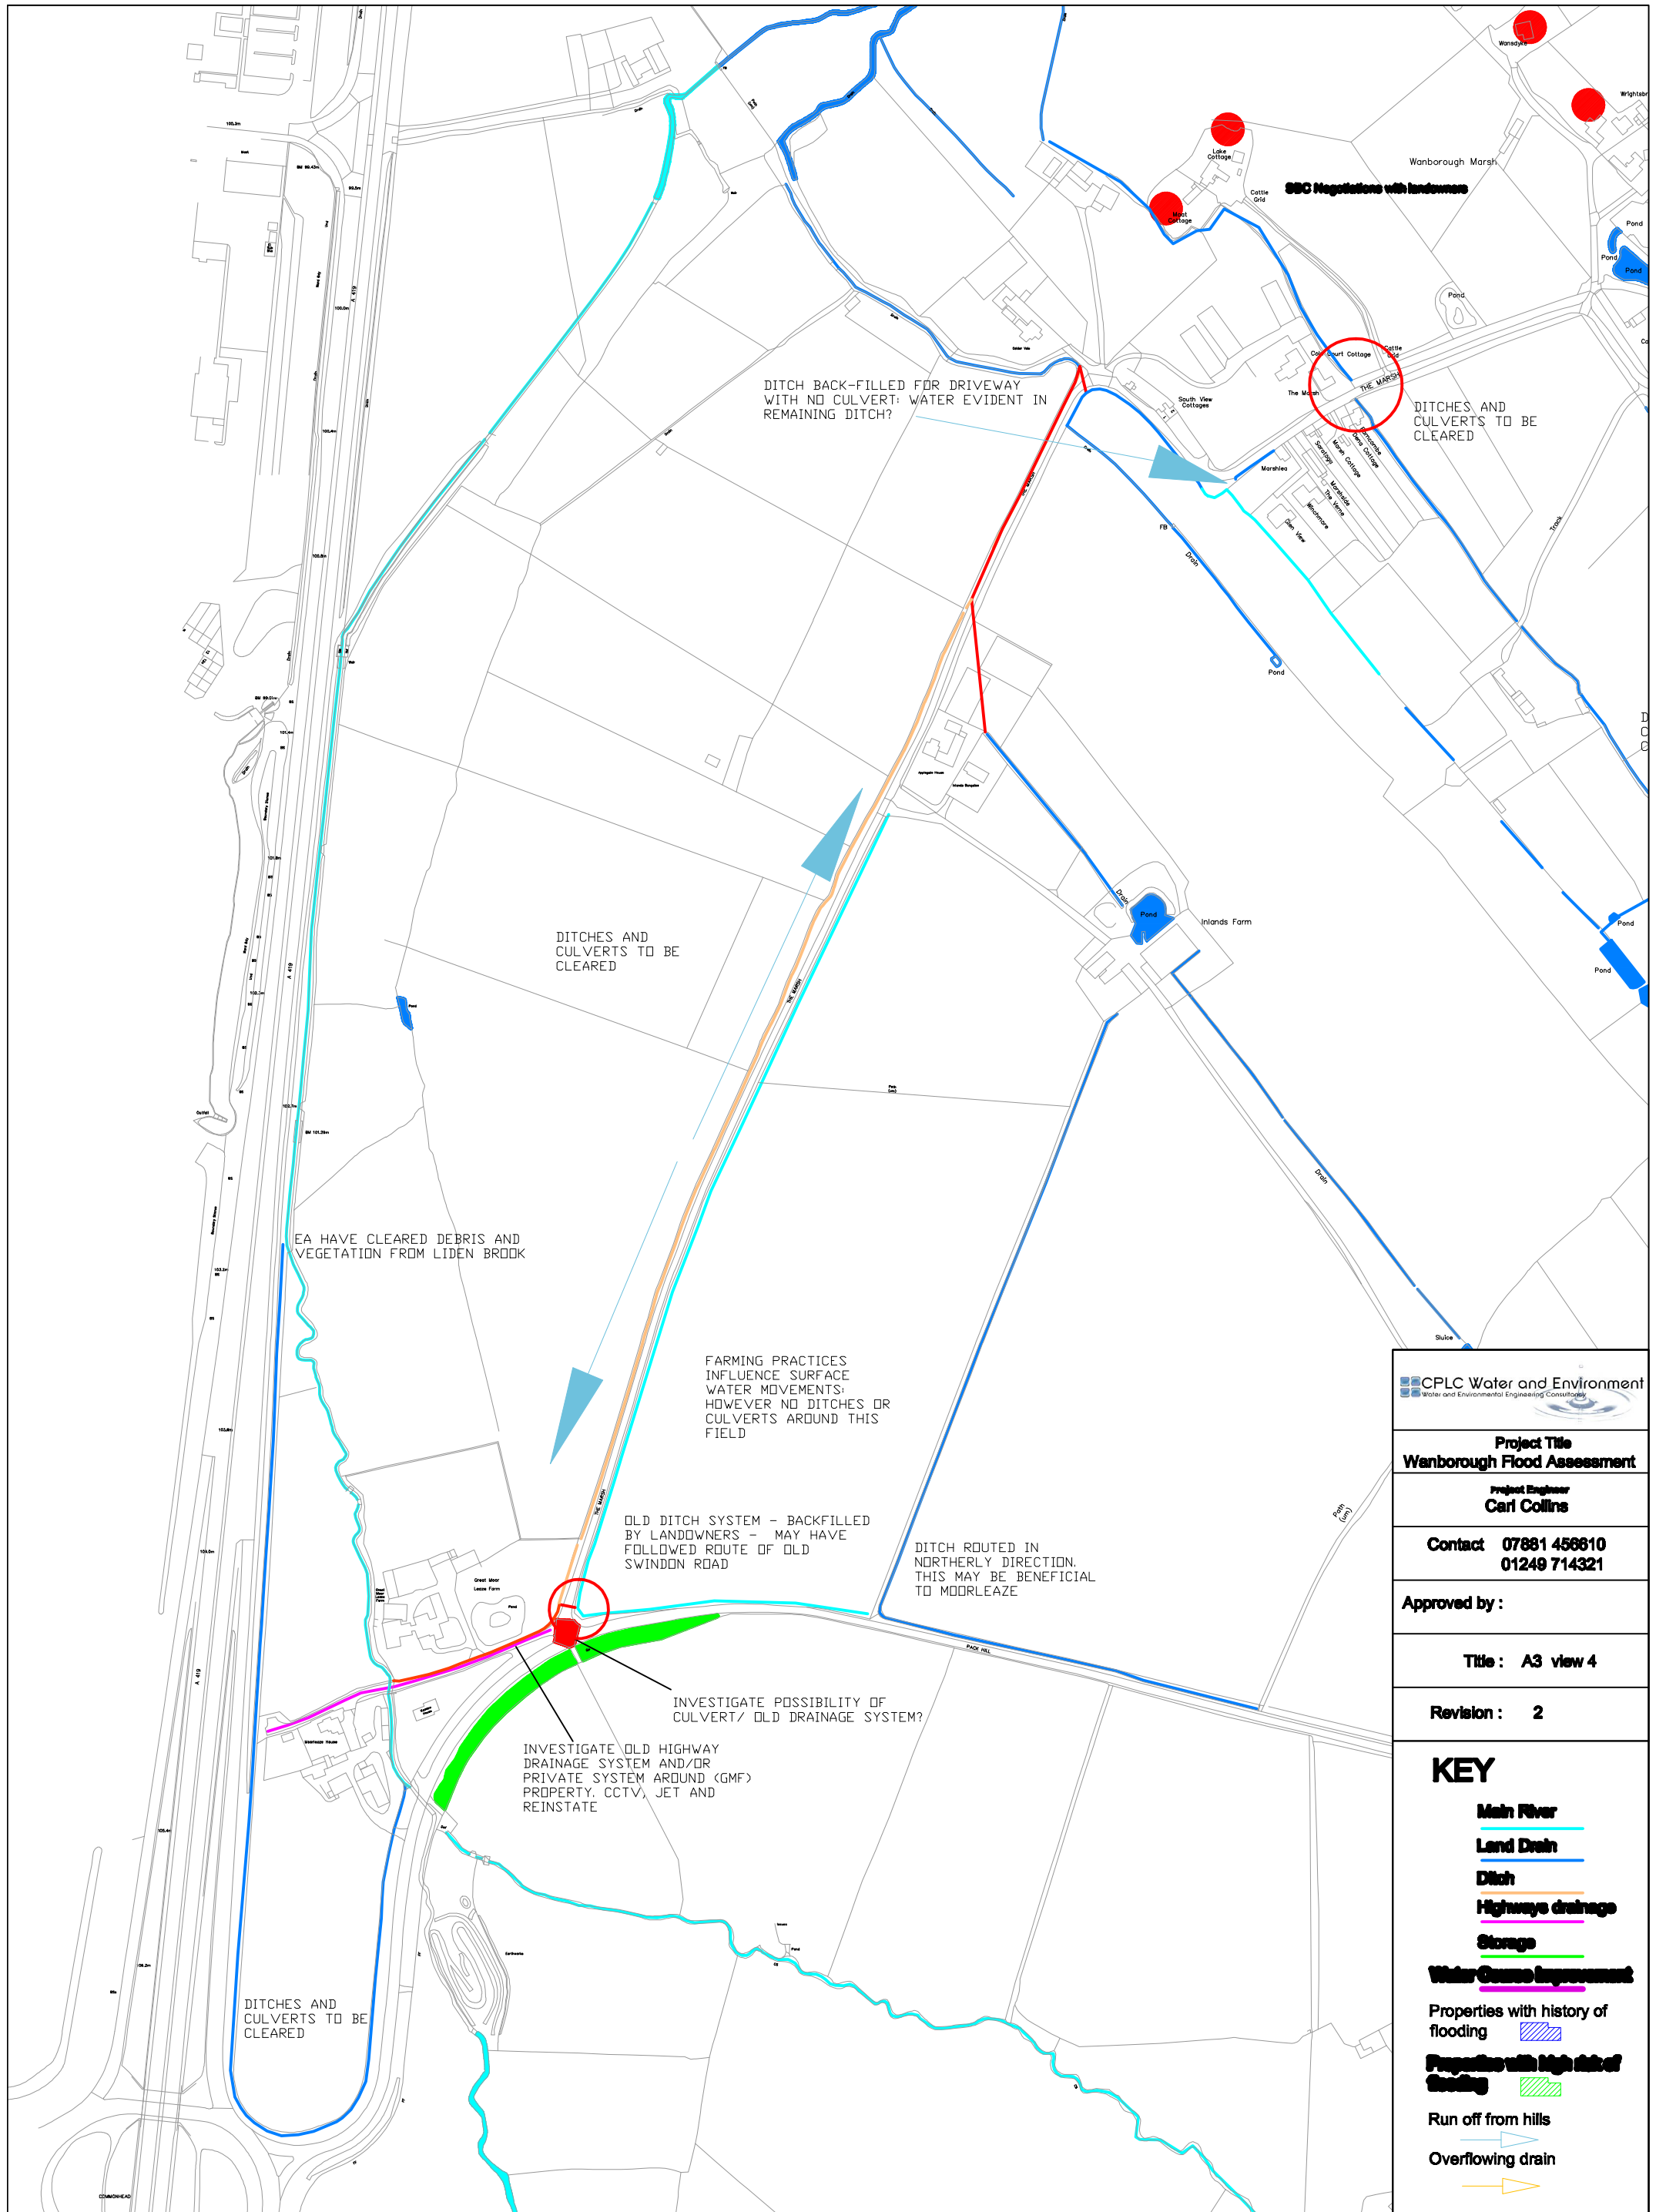
DITCH BACK-FILLED FOR DRIVEWAY WITH NO CULVERT: WATER EVIDENT IN REMAINING DITCH?

EA HAVE CLEARED DEBRIS AND VEGETATION FROM LIDEN BROOK

FARMING PRACTICES INFLUENCE SURFACE WATER MOVEMENTS; HOWEVER NO DITCHES OR CULVERTS AROUND THIS FIELD

OLD DITCH SYSTEM - BACKFILLED BY LANDOWNERS - MAY HAVE FOLLOWED ROUTE OF OLD SWINDON ROAD

DITCH ROUTED IN NORTHERLY DIRECTION. THIS MAY BE BENEFICIAL TO MODRLEAZE

DITCHES AND CULVERTS TO BE CLEARED

INVESTIGATE POSSIBILITY OF CULVERT/ OLD DRAINAGE SYSTEM?

INVESTIGATE OLD HIGHWAY DRAINAGE SYSTEM AND/OR PRIVATE SYSTEM AROUND (GMF) PROPERTY, CCTV, JET AND REINSTATE
